RTI PAST PERFORMANCE		
RTI Tracking Number:	1306594	Date: 7/11/2013
Core Task:	Fatigue Failure Testing, Chemical Analysis, Mechanical Testing, Metallurgical Testing	
Analytical Techniques	Mechanical/Hardness/Charpy/Feature /Chem/Photo

Report of Analytical Services -

RTI Lab#: 1306594-001A

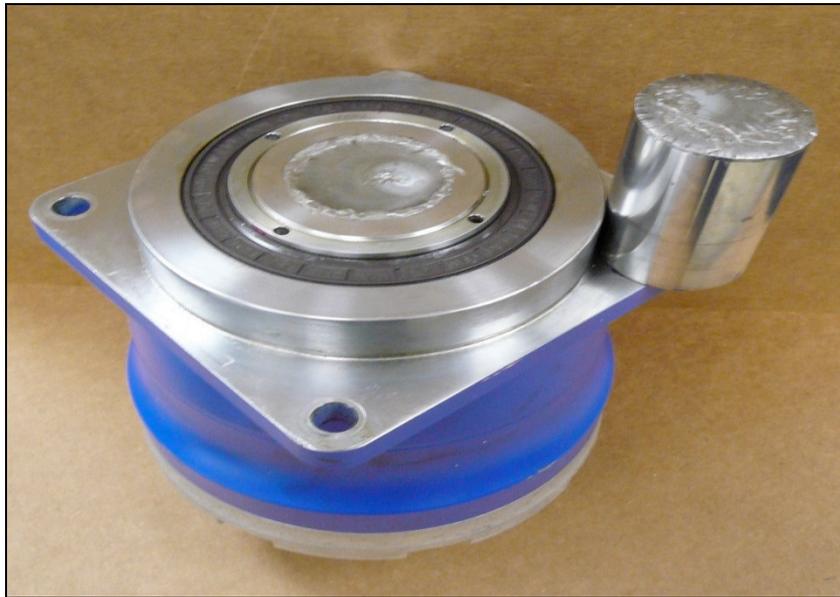
Figure 1.

The failed in service output shaft was received for analysis (See Fig 1). The target of the analysis was to investigate the nature of the failure by using a variety of the metallographic techniques. It should be noted that the supplier did not provided requested engineering drawing for outer shaft. The information provided by the client indicates that the material is 42CrMoS4+QT (DIN 1.7227+QT) with 55mm diameter and k6 tolerance. The results of the analyses are provided below.

As-received for analysis.

2. There was an abrupt change in shaft diameter and the fracture occurred at the thinnest portion of the shaft at the small fillet (See. fig.1).
3. The fracture origin is in the small fillet from undercut (see fig. 3 red arrows). The appearance of the fracture indicated that failure was due to rotation-bending load (see fig.2); the presence of undercut provided a region of stress concentration from which fatigue cracks developed. The fatigue cracks broke out circumferentially on the shaft at the undercut and developed inward. The formation of ratchet marks at undercut region indicates that the fatigue cracks were initiated at many locations around the shaft circumference (See fig. 4 red arrows).

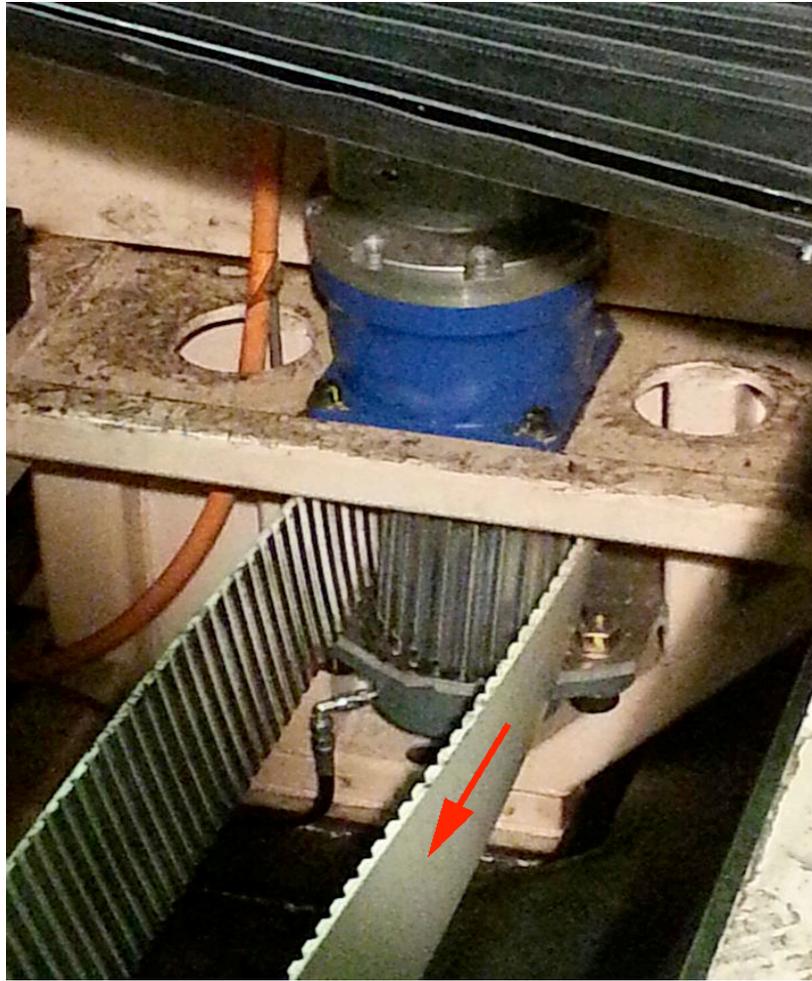
Figure 2. Image submitted by the client.
Red arrow points to direction of bending.

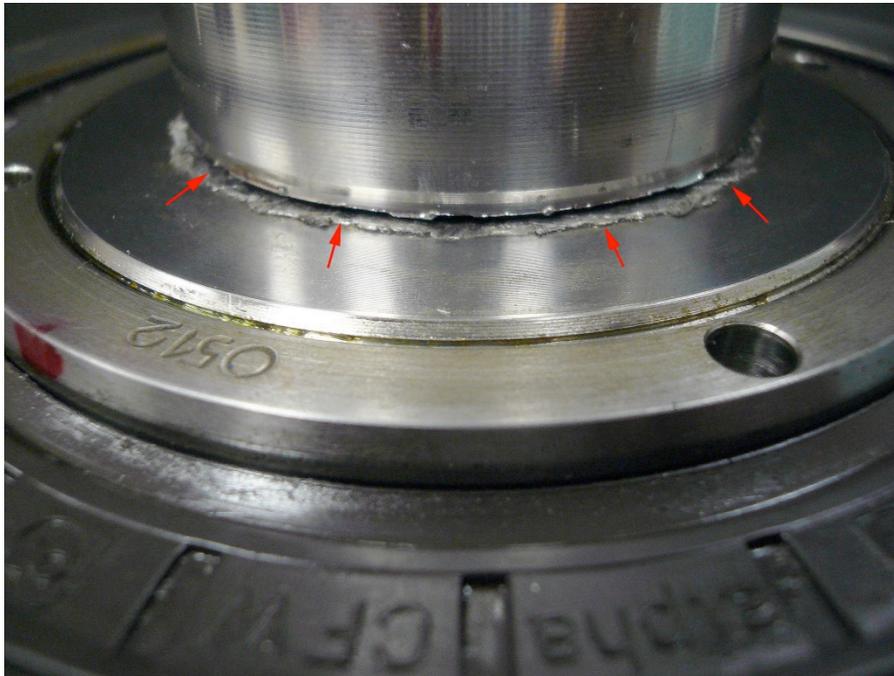
Figure 3.

Macro-image illustrates undercut at abrupt change in shaft diameter.

1. Undesirable quality of the shaft material (the amount of non-metallic inclusions in steel is too high for shaft application).
2. Undesirable (improper) heat treatment condition of the shaft material.
3. The mechanical properties below specified by DIN 1.7227+QT limits.
4. Design error – the undercut at the small filet of the shaft.
5. Assembly and/or design error – the load on the shaft was not balanced. However, the unbalanced load on the shaft can be caused by the conditions described above.

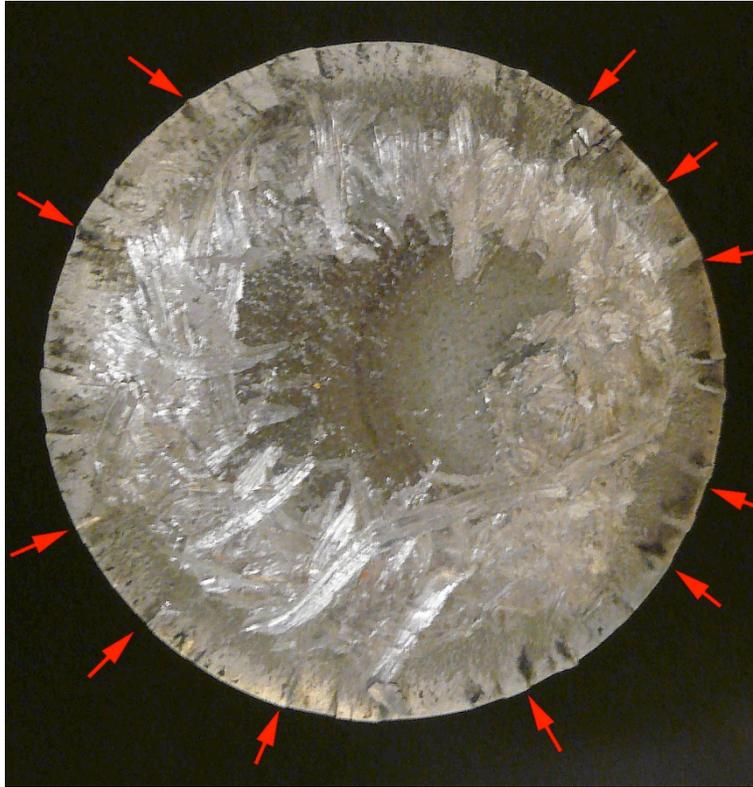
4. This fracture also illustrates a feature often shown by fatigue failures, that is, the tendency for the fracture to be dish-shaped, and the plane of fracture turning towards the section having the larger diameter (see fig. 5). Also, it is important to note that fatigue fracture propagation proceeded with arrests and produce easily recognizable beach-marks (see. fig. 4 and fig 6).

As-received for analysis. Figure 4. Reduced size
Red arrows point to the ratchet marks.

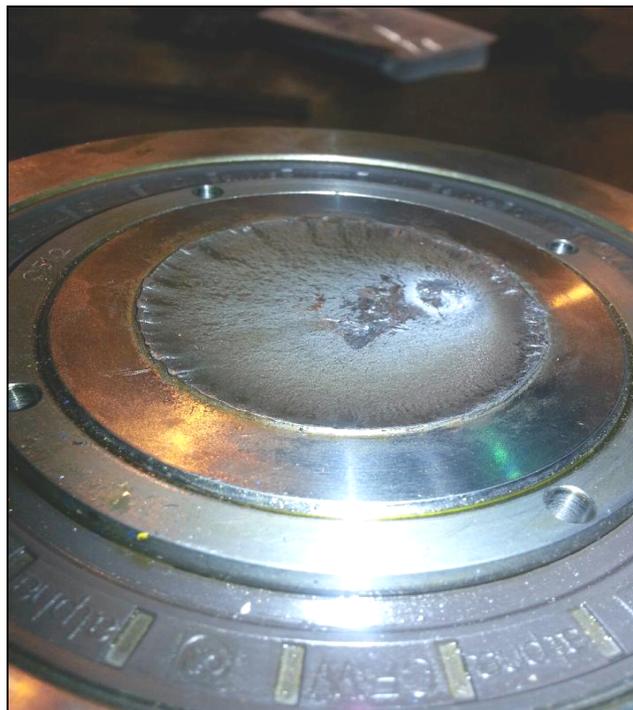
Figure 5. Image submitted by the client.

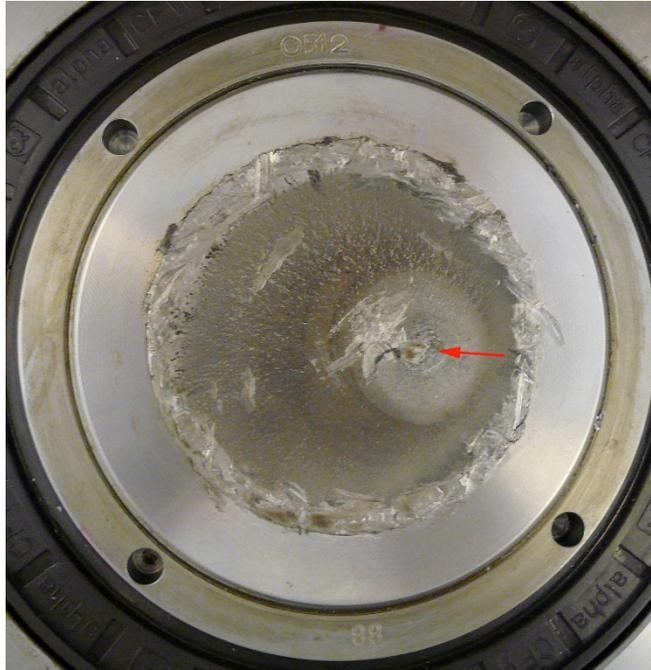
5. The fatigue cracks propagate inward almost through the entire cross-section and then final and sudden overload fracture occurred off center (see fig. 6). The eccentric pattern of beach-marks and off center final overload fracture indicates that load on the shaft was not balanced.

As-received for analysis. Figure 6. Reduced size
Red arrow point to the location of final overload fracture.

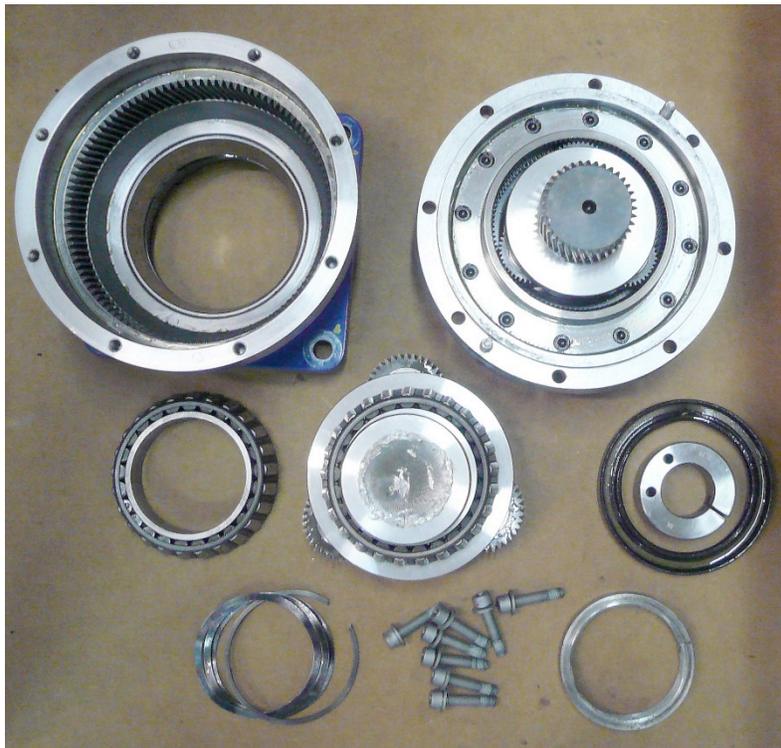
6. To further the investigation the gearbox assembly was disassembled. The roller bearings, gear teeth and inner portion of the shaft revealed no evidence of wear, overheating or plastic deformation (see fig. 7 and fig. 8).

Figure 7. Reduced size
Macro-image illustrates components of gearbox assembly.

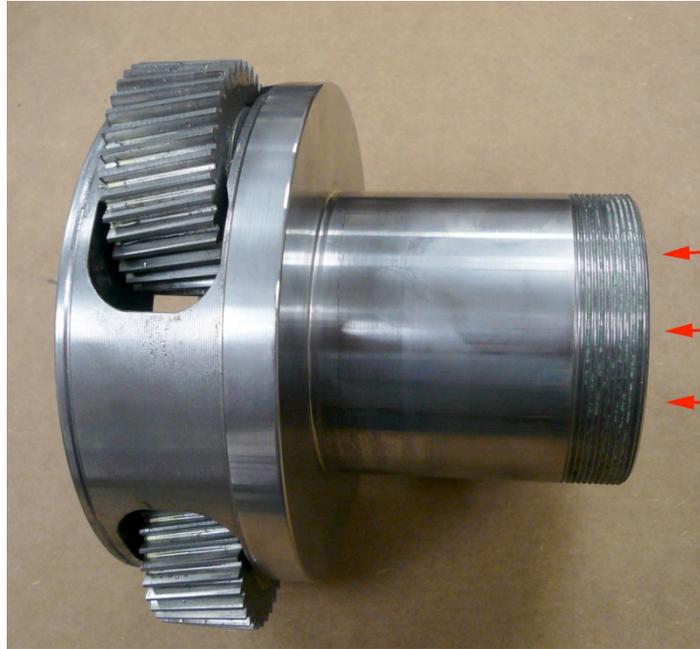
Figure 8. Reduced size
Macro-image illustrates inner portion of the shaft.
Red arrows point to the fractured region.

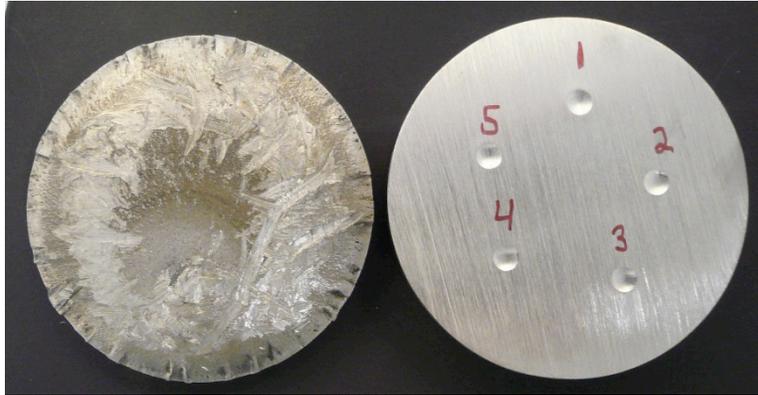
Hardness (HBW)* readings were taken at the mid-radius of the transverse cross-section of the shaft (see fig. 9). The surface was carefully polished prior to the hardness testing.

Designation	Reading
1	255
2	248
3	248
4	248
5	248

Figure 9. Reduced size.
Marco-image illustrates locations of hardness indentations.

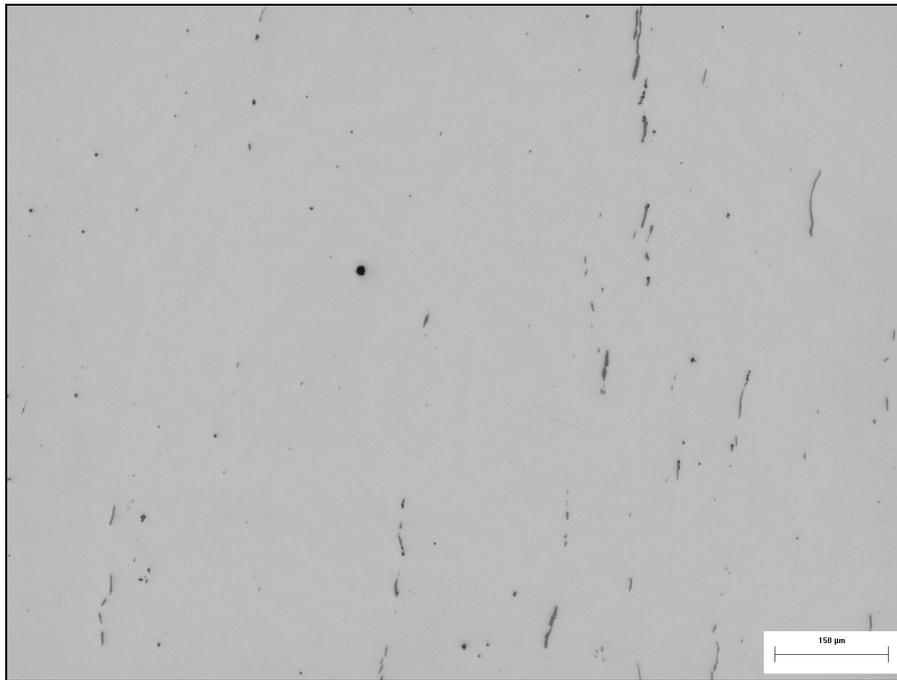
It should be pointed out that the higher amount of internal discontinuities such as soft manganese sulfide (MnS) non-metallic inclusions (rated 2½) in shaft material would contribute to premature failure.

As-polished condition. Figure 10. 100x
Micro-image of a representative structure.

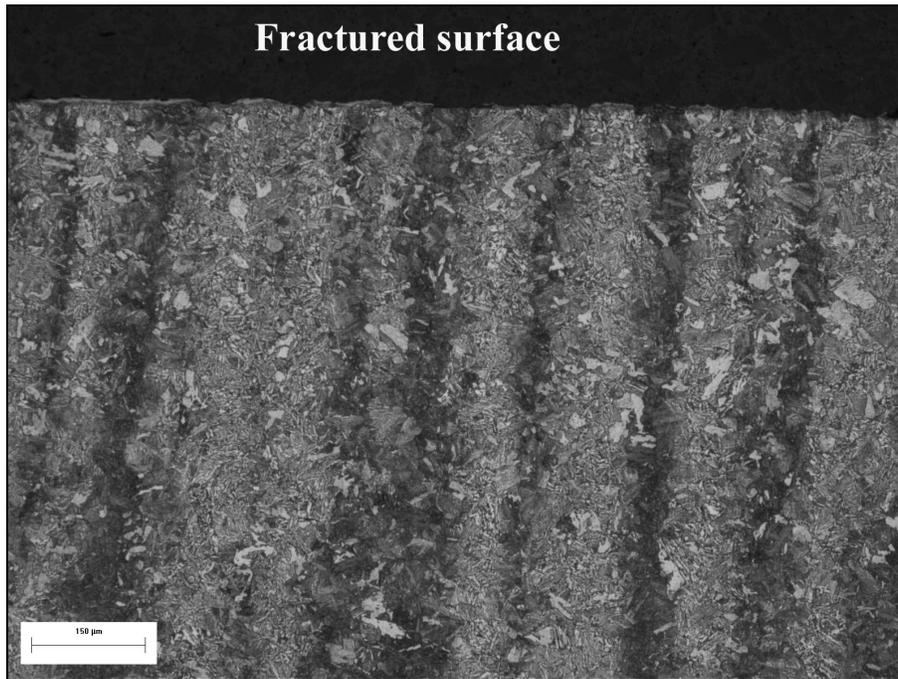
Metallographic examination of the etched cross-section revealed inhomogeneous microstructure, which consists of alternating bands of acicular ferritic with fine pearlitic colonies and dense fine lamellar pearlite colonies (see fig. 11 and fig. 12). It should be noted that the typical microstructure for (DIN 1.7227+QT) material in Quenched and Tempered condition is tempered martensite. Also, banded structure is very sensitive to the transverse bending loading.

Etched condition Figure 11 100x
Micro-image of a representative structure.

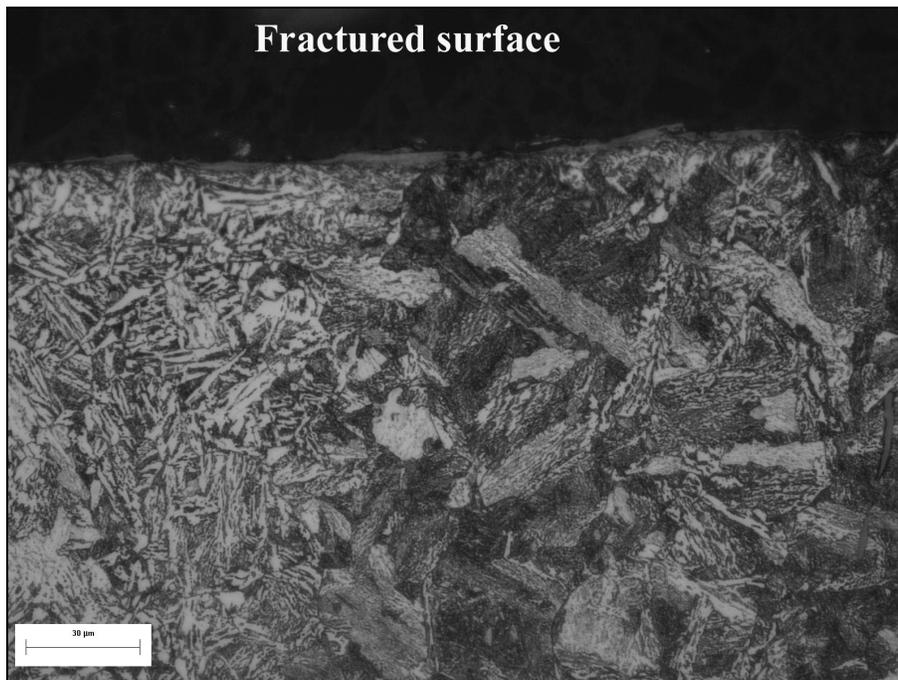
Etched condition Figure 12 500x
Micro-image of a representative structure.
