RTI PAST PERFORMANCE		
RTI Tracking Number:	1307139	Date: 7/3/2013
Core Task:	Metallurgical Testing	
Analytical Techniques	Metallurgical

REPORT OF ANALYTICAL SERVICES

RTI Lab#: 1307139-001A

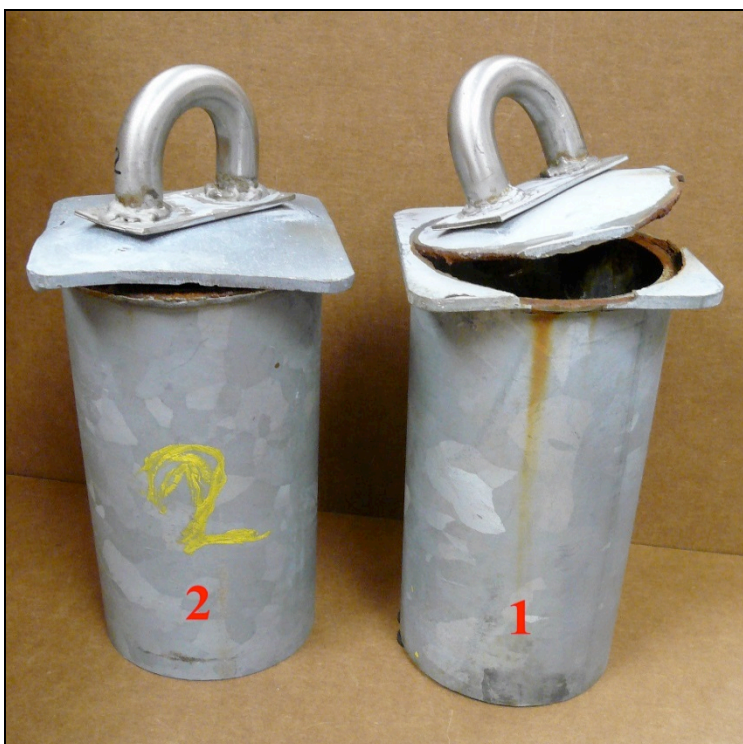
Figure 1.

Two (2) failed in service roof anchors were received for analysis (See Fig 1). The target of the analysis was to investigate the nature of the failure by using a variety of the metallographic techniques. It should be noted that the client did not provide engineering drawing and /or service manual for roof anchors. The results of the analyses are provided below.

As-received for analysis.

2. Both roof anchors appear to experience angular tension loading (most likely cycle loading – which is evident in the fractured steps throughout the failed welded region) for some period of time. The fracture occurred at the opposite side from the tension load (see fig1).

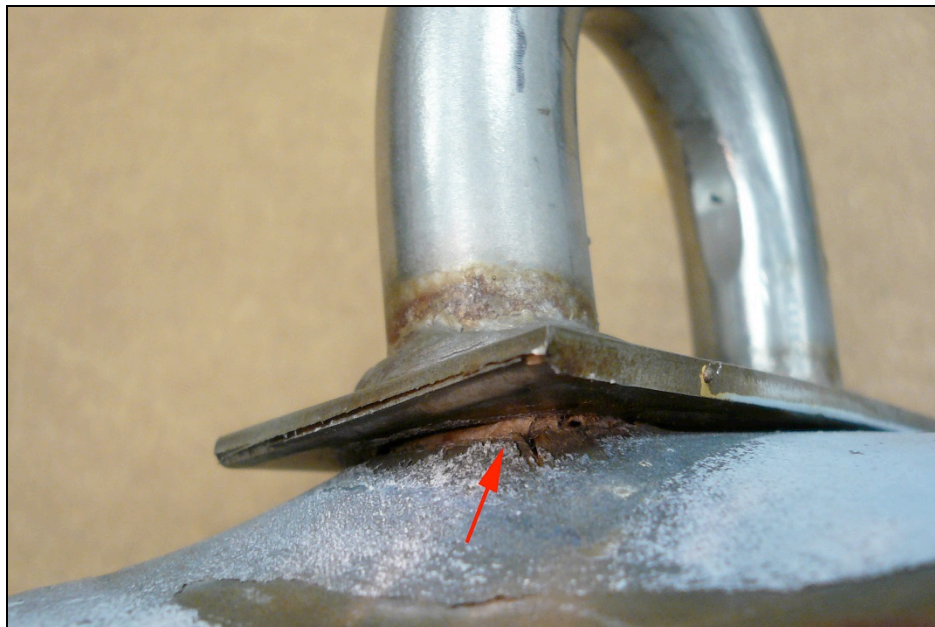
Figure 2.

3. The angular tensile load was so severe that cause plastic deformation of the round top plate and yielding of the U-bolt holes (see fig. 2). It should be pointed out that, the plastic deformation of the U-bolt holes unsealed the inner chamber of the roof anchor and exposed to the external environment.

Red arrow points to the failed region.

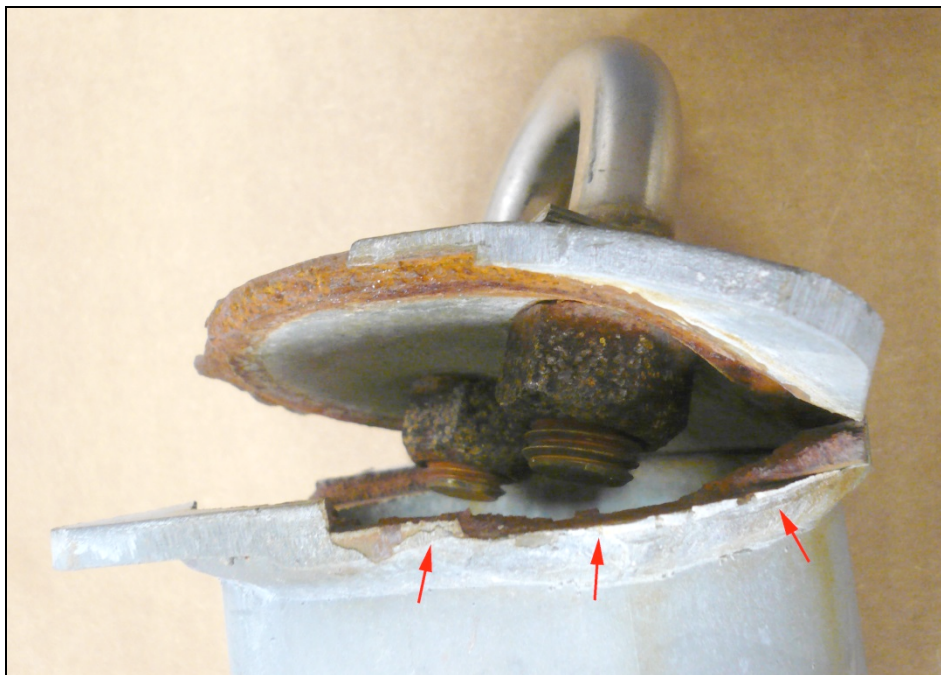
4. The evidence of the severe corrosion of the nuts in the inner threaded portion of the U-bolts in compressing to the rest of the inner surfaces of the roof anchor confirms original entrance of the condensate (see fig. 3 and fig. 5).

7. The final catastrophic fracture occurred between circumferential weld interface and top round plate (see fig. 3 & fig.4).

As-received for analysis. Figure 3. Reduced size.
Roof anchor #1. Red arrows point to the fractured region.

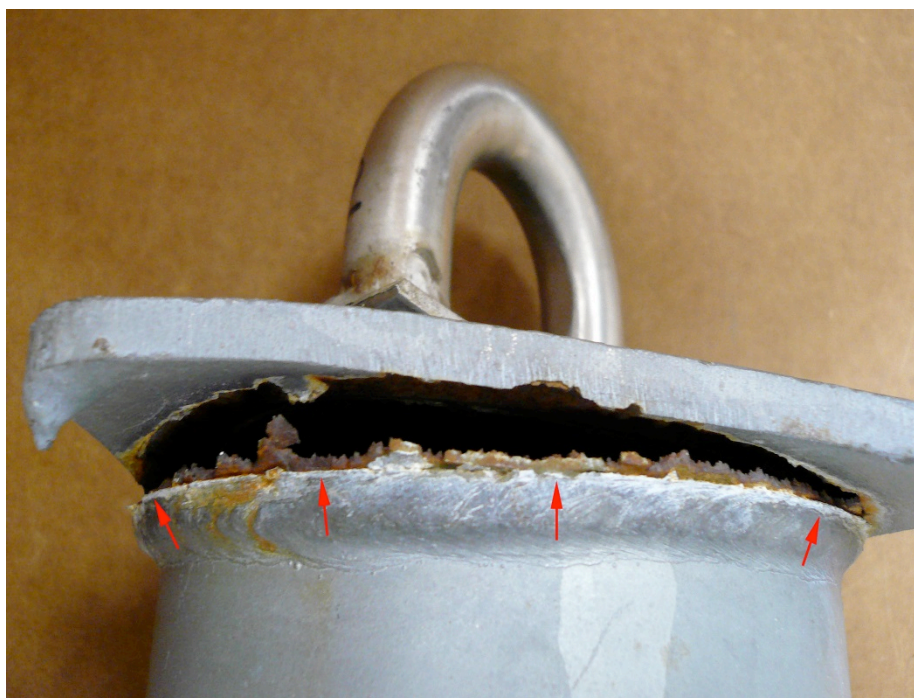
As-received for analysis. Figure 4. Reduced size.
Roof anchor #2. Red arrows point to the fractured region.

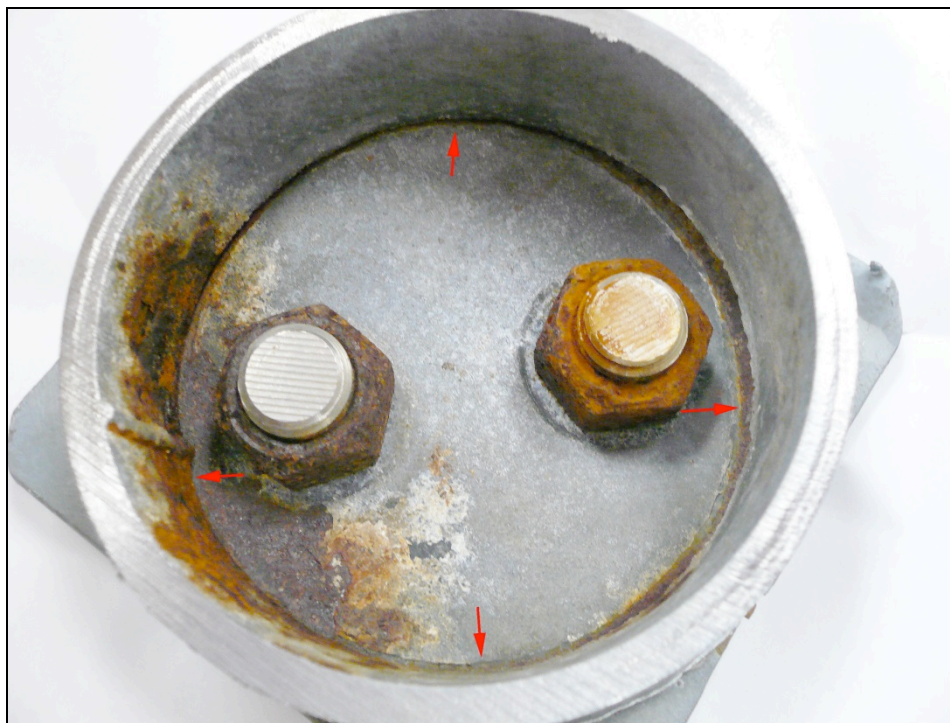
5. In both samples condensate also precipitated at the circumference at the root portion of the weld between tube and top round plate (see fig.5) and ceased crevice corrosion.

As-received for analysis. Figure 5. Reduced size.
Roof anchor #2. Micro-image illustrates inner condition of the roof anchor.

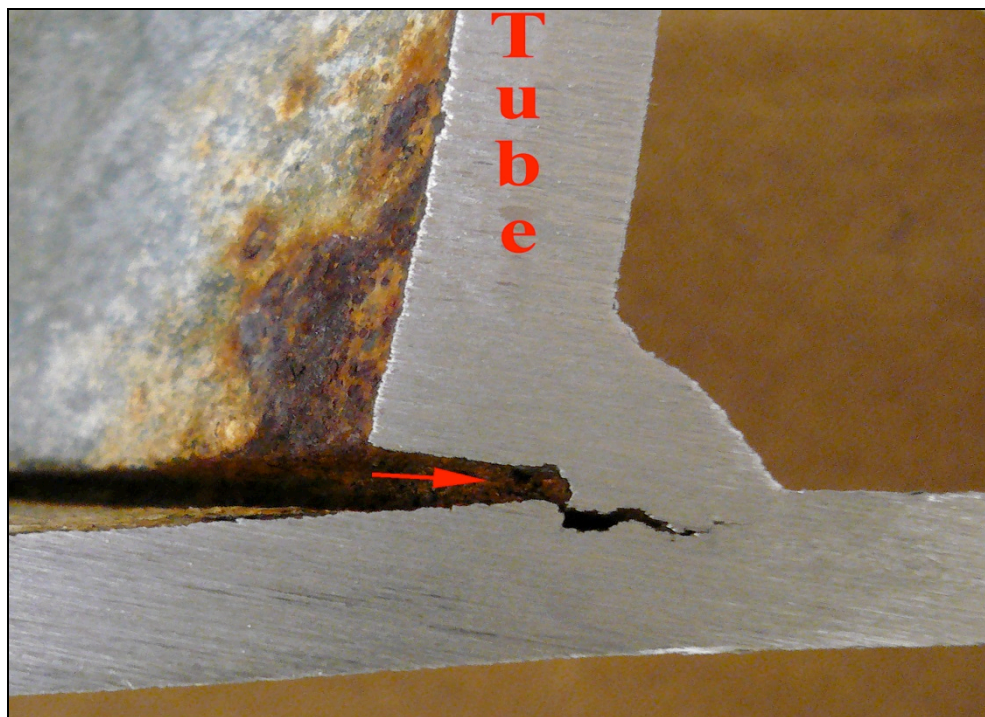
6. The circumferential crack also originated at the root portion of the weld and propagate in steps (indication of the cycle loading) toward the weld face (see fig.6).

As cross-section condition. Figure 6. Reduced size.
Roof anchor #2. Macro-image illustrates origin of the fracture (red arrow).

To further the investigation Roof anchor #2 was sectioned transversally throughout fractured region (see fig. 6), metallographically prepared in accordance with ASTM E3-11, and microscopically examined in the as-polished and etched conditions.

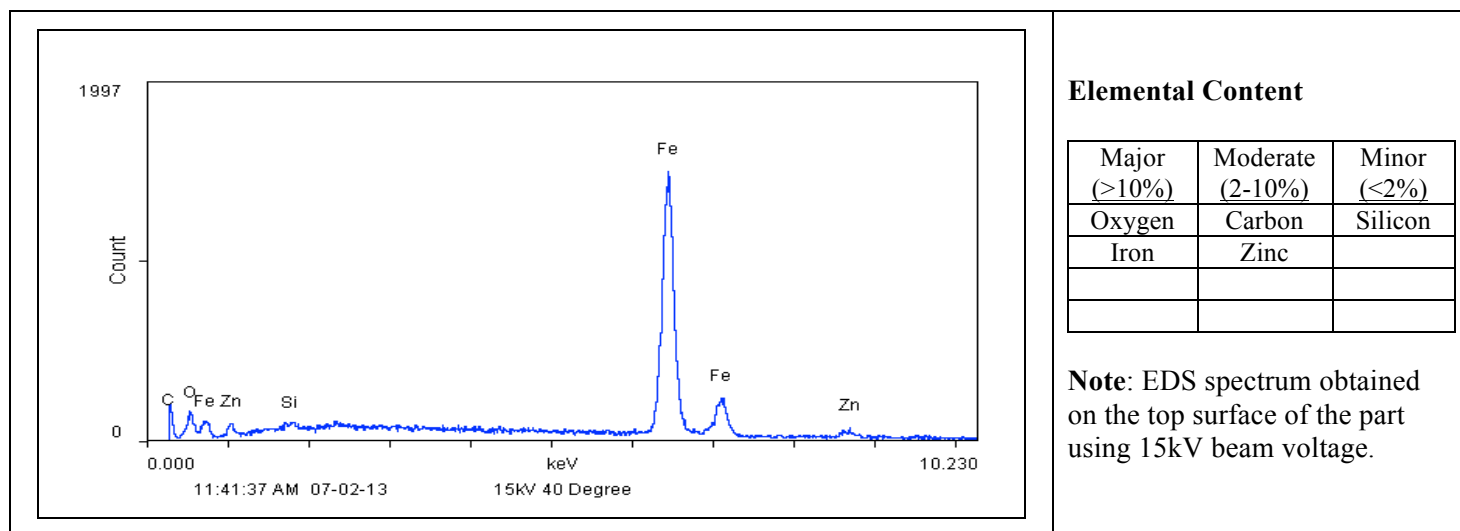
Note: Based on the elemental analysis of the corrosion product it can be concluded that the fractured surface has no evidence of specific ions or substances that have been known to cause and/or accelerated corrosion.

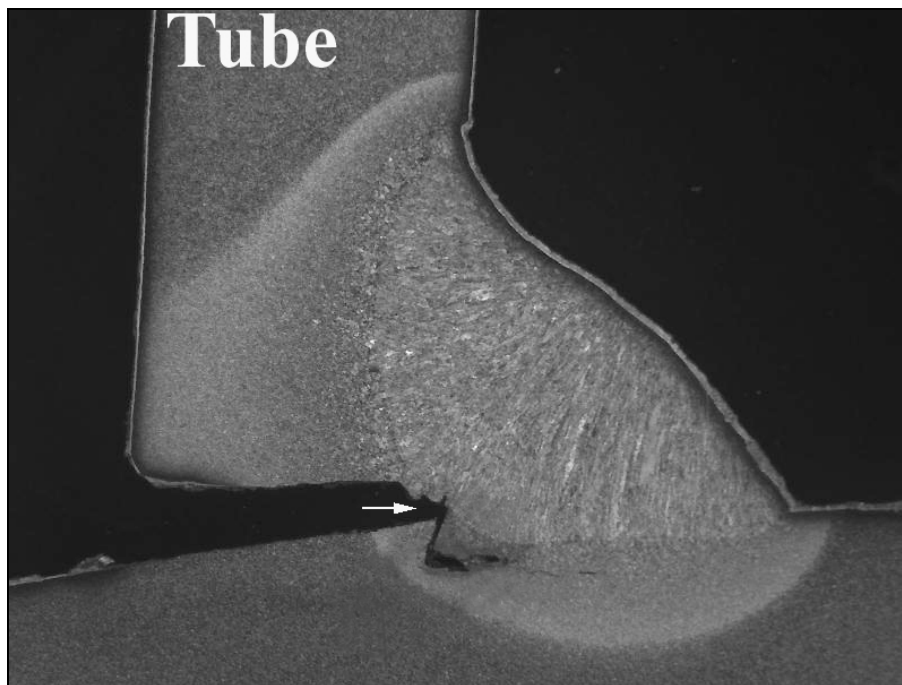
Metallographic examination of the etched cross-section revealed that the fracture originated at the root portion of the weld and propagated throughout heat-affected re-crystallized region at the round plate side (see fig. 7). It should be noted that the weld also has very shallow fusion at the failed region. Undercut is also present. The microscopic examination of the fracture revealed tearing (tensile overload) morphologies (see fig. 8).

Etched condition. Figure 7 7x
Micro-image illustrates transverse cross-section fractured region.

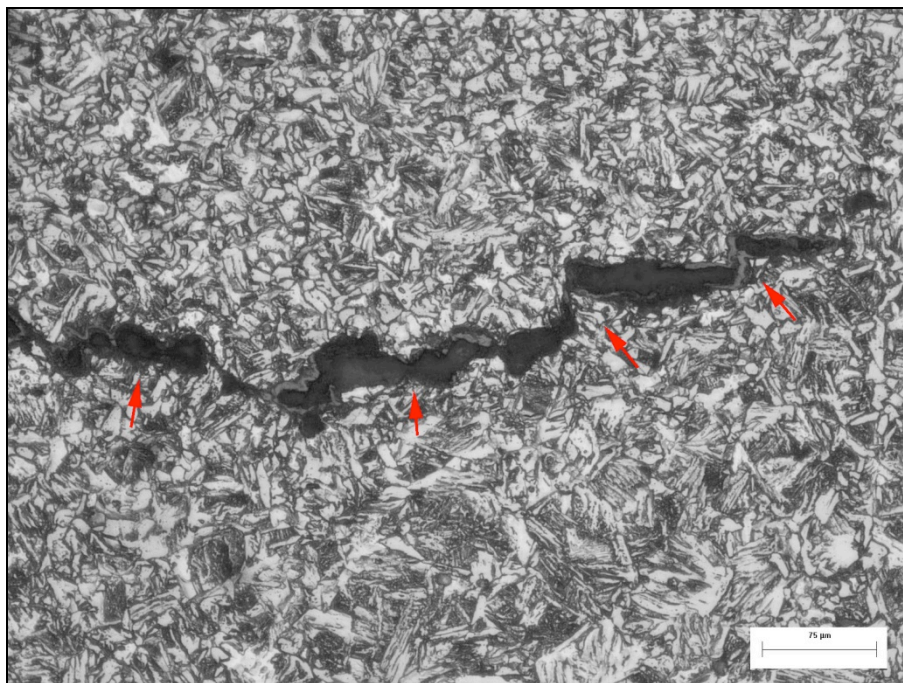
Etched condition. Figure 8 200x
Micro-image illustrates tearing morphologies.

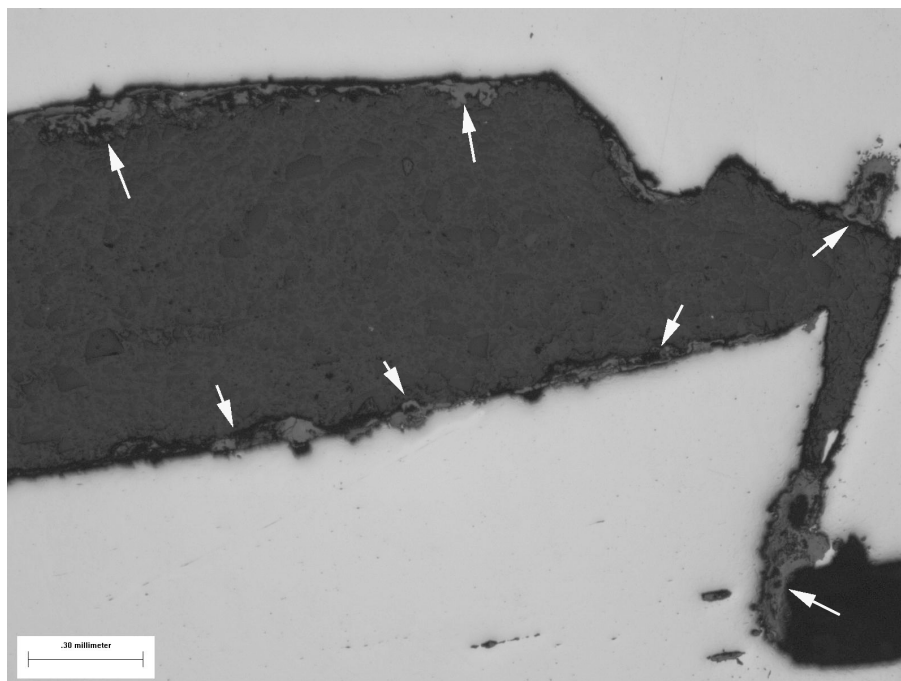
Metallographic examination of the as-polished cross-section revealed some corrosion product at the fracture surfaces (see fig. 9 & fig. 10). However, there was no evidence of severe corrosion attack, which can promote catastrophic failure. In addition, the fracture associated with heavy series of alumina type non-metallic inclusions (see fig. 10 & fig. 11). It should be pointed out that the residual stress at the welded region and numerous case non-metallic inclusions will decrease strength of the welded joint to any tensile loading.

As polished condition Figure 9. 50x
Micro-image illustrates corrosion product at the origin of the fracture.

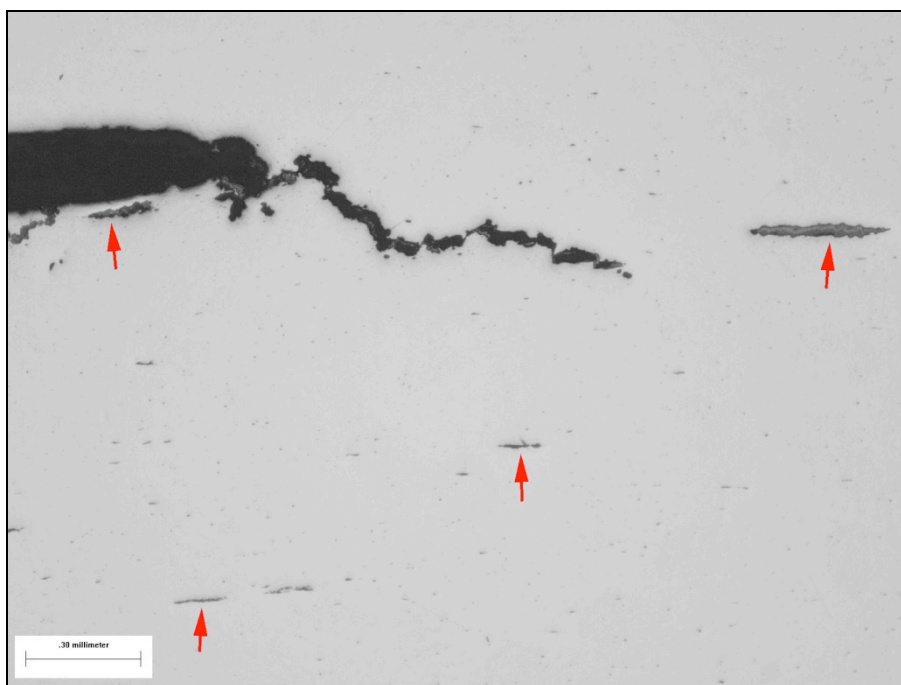
As polished condition Figure 10. 50x
Micro-image illustrates corrosion product at the end portion of the fracture.

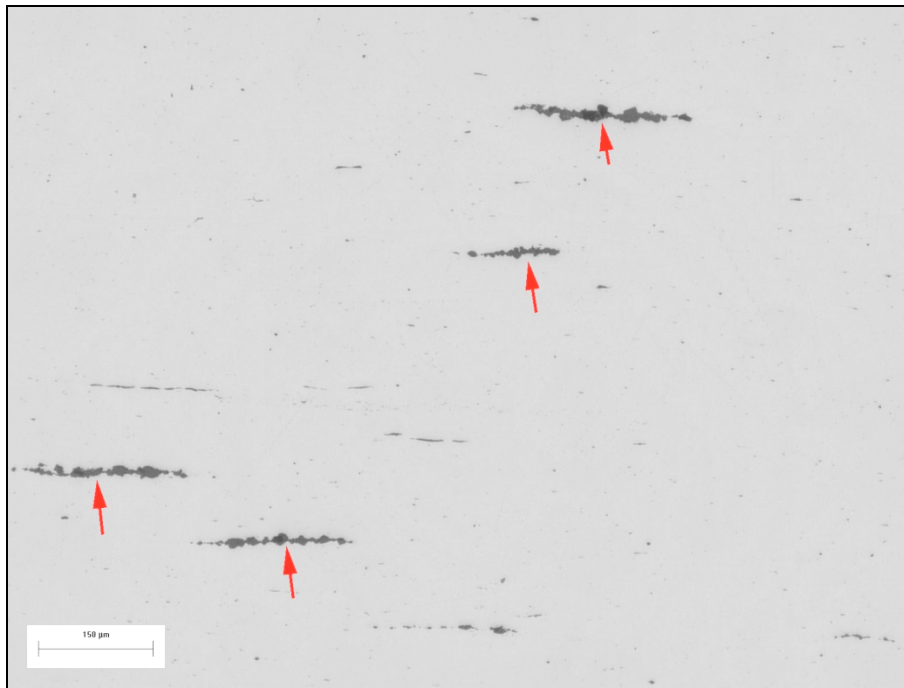
As polished condition Figure 11. 100x
Micro-image illustrates numerous heavy series of alumina type non-metallic inclusions in the round plate matrix.
