RTI PAST PERFORMANCE				
RTI Tracking Number:	1311278	Date: 11/15/2013		
Core Task:	Metallurgical Testing, Chemical Analysis			
Analytical Techniques	Feature/EDS/FTIR/Photo/SEM/EDS

Four total samples were received for analysis and were identified as follows:

- 1 No rubber to plastic failure 1
- 2 No rubber to plastic failure 2
- 3 Rubber to plastic insert bond failure 1
- 4 Rubber to plastic insert bond failure 2

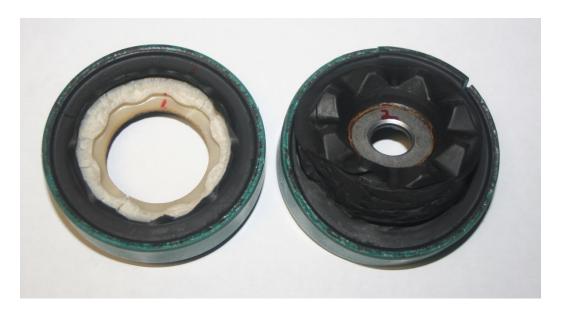
Examination of samples 1 and 2 do not show any failure substrate therefore a section was cut from each part to examine the film build at the rubber to inner plastic interface. Samples 3 and 4 were received with catastrophic failure to the insert substrate almost entirely around the circumference with little evidence of rubber tear. The samples as received are provided as Figures 1 and 2. For samples 3 and 4, the insert sections were isolated by completing the rubber tear. Sections were cut from each insert for analysis by EDS, FTIR and film build. The mating rubber backs from samples 3 and 4 were also isolated for examination by EDS and FTIR. In addition, bulk sections of the insert plastic and rubber were analyzed for baseline substrate information.

Cross-section analysis for dry film thickness at the substrate for samples 1 and 2 indicates a nominal reading of 42.0 microns (1.6mils) for sample 1 and 29.1 microns (1.1mils) for sample 2. Cross-section analysis of the dry film thickness for samples 3 and 4 at an area of slightly retained rubber indicates a nominal reading of 71.9 microns (2.8mils) for sample 3 and 63.0 microns (2.5 mils) for sample 4.

Figure 1 – Samples 1 and 2 No rubber to plastic failure

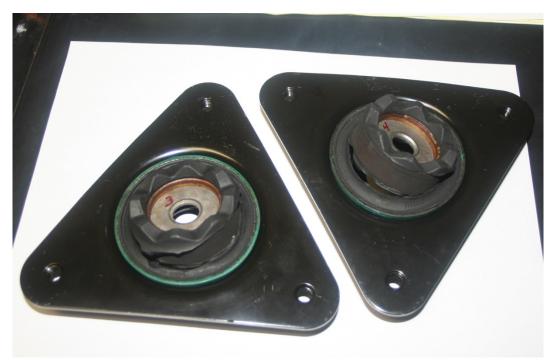
Samples 3 and 4 – Rubber to plastic bond failure samples

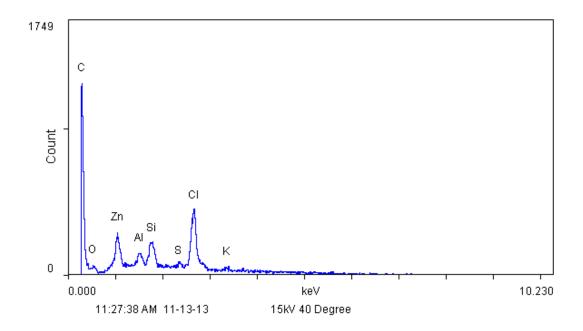
Examination of the two substrate samples by EDS indicate the dominant presence of elements associated with a Chemlok 6253 adhesive system with no elemental indication of foreign contaminants. For sample 3, however a significant increase in carbon level compared to the other substrate examined indicates more underlying substrate presence (or thinner adhesive in this region). Examination of the two mating rubber backs by EDS indicate the dominant presence of elements associated with a Chemlok 6253 adhesive system with no elemental indication of foreign contaminants.

Figure 3 – EDS spectrum obtained from the Sample 3 Failure Substrate - Major elements (>10%) – carbon, oxygen; Moderate elements (2-10%) – chlorine, zinc, silicon; Minor elements (0.2-2%) – sulfur, aluminum, potassium

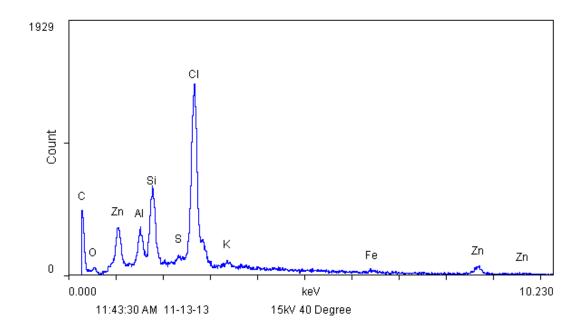
Figure 4 – EDS spectrum obtained from the Sample 3 Mating Rubber back - Major elements (>10%) – chlorine, carbon, oxygen; Moderate elements (2-10%) – zinc, silicon, aluminum; Minor elements (0.2-2%) – potassium, sulfur, iron

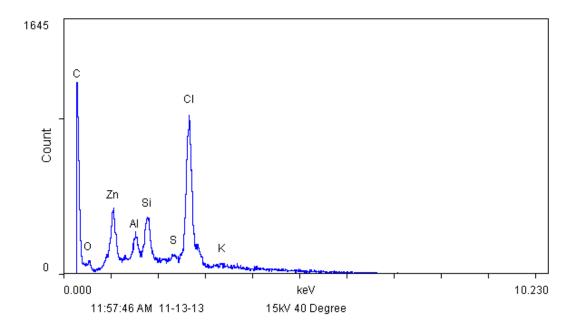
Figure 5 – EDS spectrum obtained from the Sample 4 Failure Substrate - Major elements (>10%) – chlorine, carbon, oxygen; Moderate elements (2-10%) – zinc, silicon; Minor elements (0.2-2%) – potassium, sulfur, aluminum

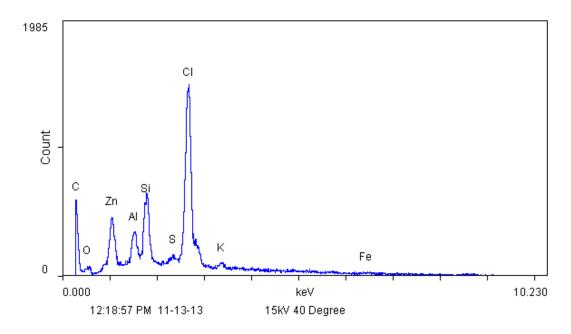
Figure 6 – EDS spectrum obtained from the Sample 4 Mating Rubber Back - Major elements (>10%) – chlorine, carbon, oxygen; Moderate elements (2-10%) – zinc, silicon; Minor elements (0.2-2%) – potassium, sulfur, aluminum, iron

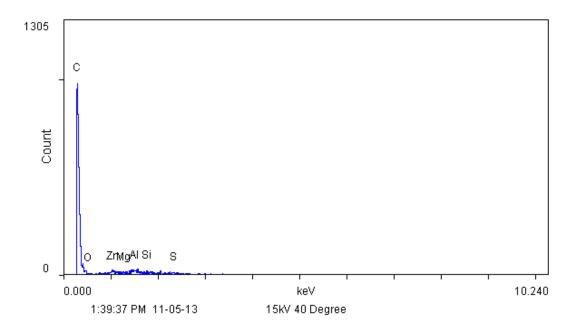
Figure 7 – EDS spectrum obtained from the bulk rubber sample for baseline levels - Major elements (>10%) – carbon; Moderate elements (2-10%) – none; Minor elements (0.2-2%) – zinc, oxygen, magnesium, aluminum, silicon, sulfur

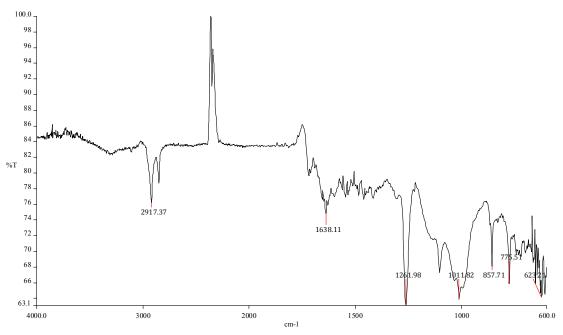
Examination of the two substrate samples by FTIR indicate molecular absorbance indicative of functional groups of polymeric hydrocarbon, carbonyl, alkoxylation, nitrogen containing and halide containing organics. The same primary absorbance bands were noted at the mating rubber backs, with no indication of molecular absorption due to the underlying substrates. It is of noteworthy mention, however, that for the substrates examined for samples 3 and 4, a significant decrease was noted in the carbonyl band intensity compared to the mating rubber back samples. This is indicative of a discontinuity in composition across the adhesive profile that is not explained by simply the bonding process (as original levels are noted at the mating rubber back in the bonded samples).

Figure 8 – FTIR spectrum obtained from the Sample 3 Substrate

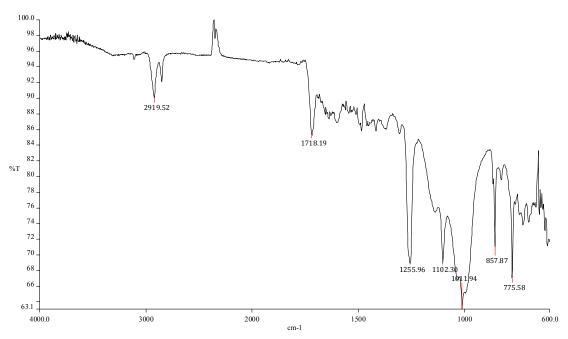
Figure 9 – FTIR spectrum obtained from the Sample 3 Mating rubber back

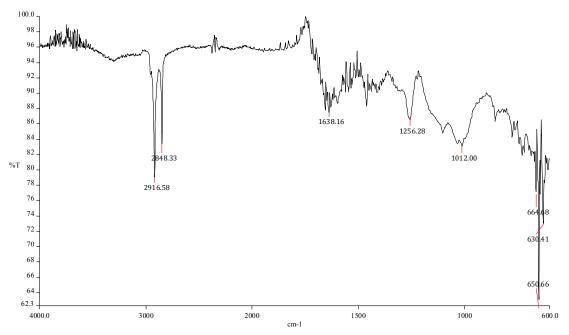
Figure 10 – FTIR spectrum obtained from the Sample 4 Substrate

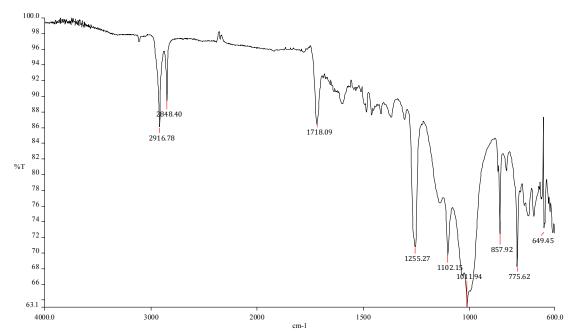
Figure 11 – FTIR spectrum obtained from the Sample 4 Mating rubber back

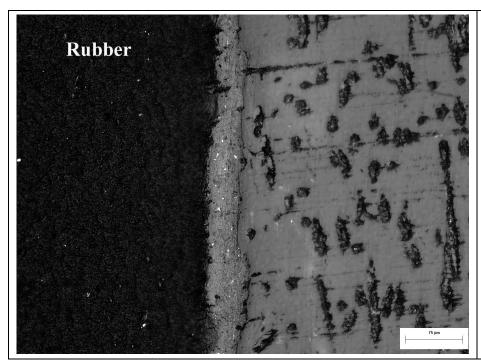
Figure: 16

Description	Layer	Min. Thickness	Max. Thickness	Average
Sample #1	Adhesive	31.85 (μm)	57.79 (μm)	42.04 (μm)
Sample #2	Adhesive	22.96 (μm)	33.34 (μm)	29.14 (μm)
Sample #3	Adhesive	67.60 (μm)	78.57 (μm)	71.94 (μm)
Sample #4	Adhesive	56.30 (μm)	68.89 (μm)	62.96 (μm)

Comments: Micro-image illustrates distribution of the coatings on plastic substrate.

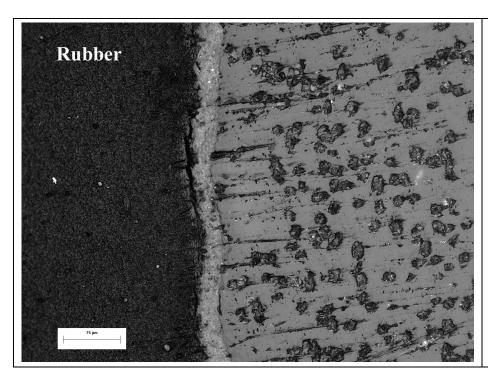
Figure: 17

Comments: Micro-image illustrates distribution of the coatings on plastic substrate.

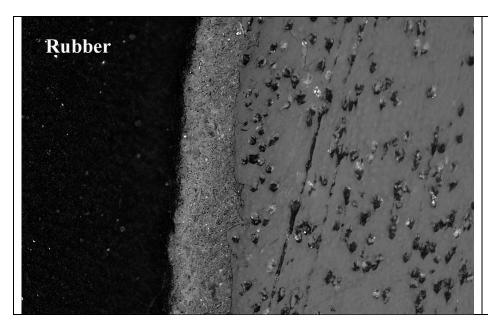
Figure: 18

Comments: Micro-image illustrates distribution of the coatings on plastic substrate.

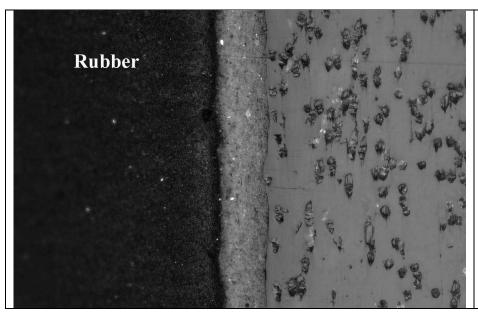
Figure: 19

Comments: Micro-image illustrates distribution of the coatings on plastic substrate.
