| RTI PAST PERFORMANCE | | |
| Core Task: | Mechanical Testing, Metallurgical Testing, Fatigue Failure Testing | |

A motor assembly with a shaft failure was received for analysis. The target of the analysis was to investigate the failure mode and materials properties using a variety of metallographic techniques. The results of the analysis are discussed below.

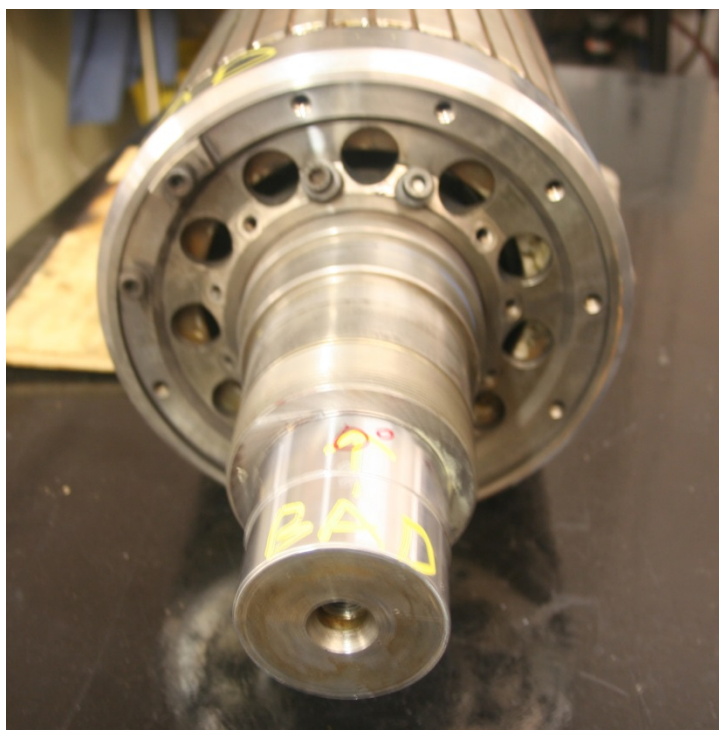
A complete wrapped motor assembly was received in the laboratory. Upon removal of the wrapping material, a large crack was noted circumferentially around the shaft at the reduced section machining radius. The shaft and features were photodocumented as below, with the initial crack at the 0 deg position, and the 3 other quadrants identified clockwise in the crack propagation direction.

**Figure 1 – As received motor and exposed shaft**

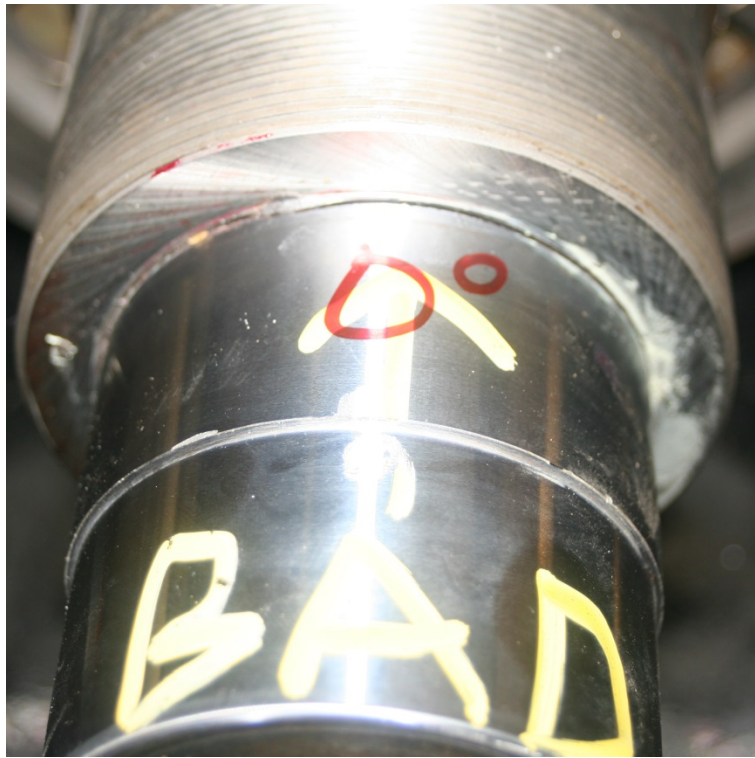
Figure 2 – 0 degree and crack origin

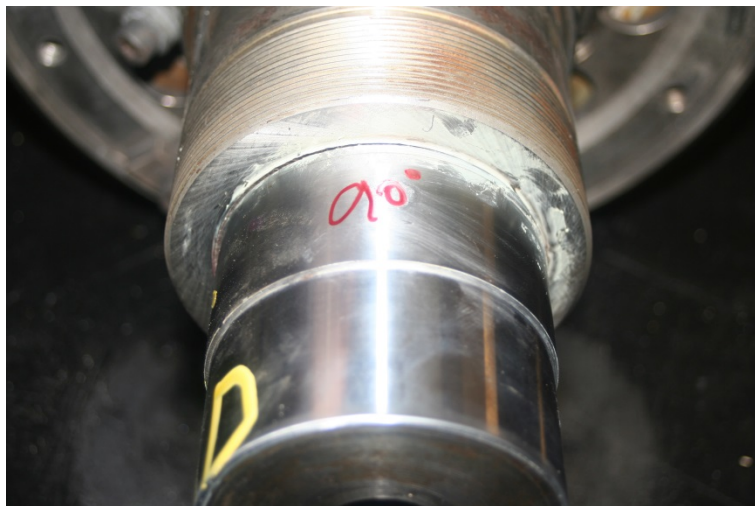
Figure 3 – 90 degree crack propagation

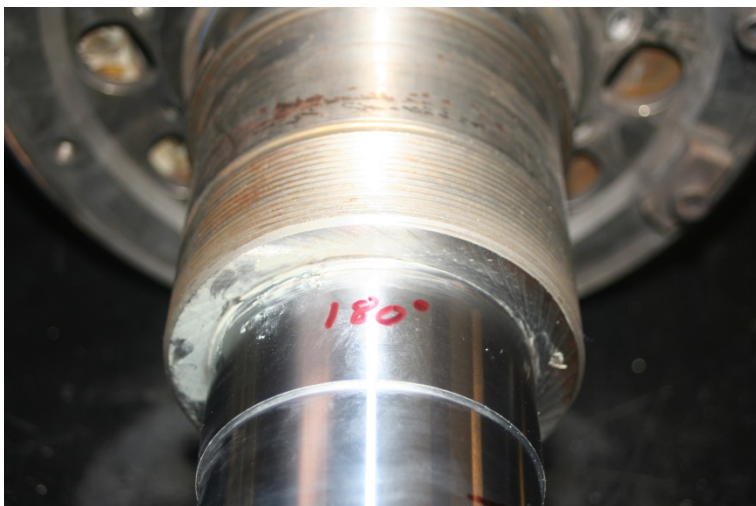
Figure 4 – 180 deg crack propagation

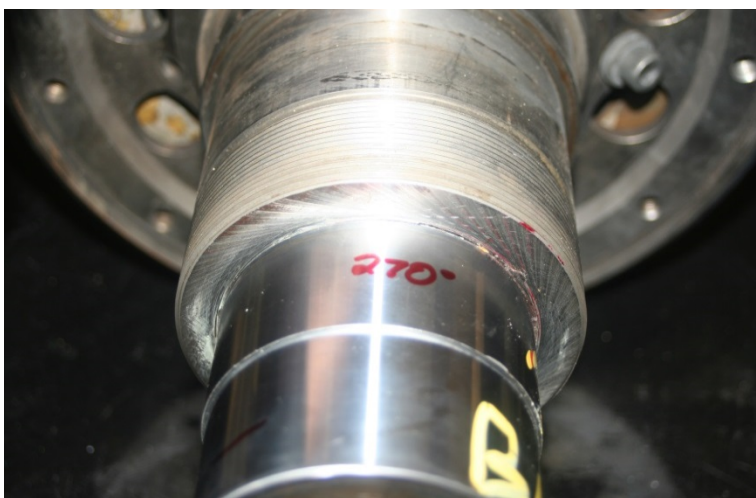
Figure 5 – 270 degree crack propagation

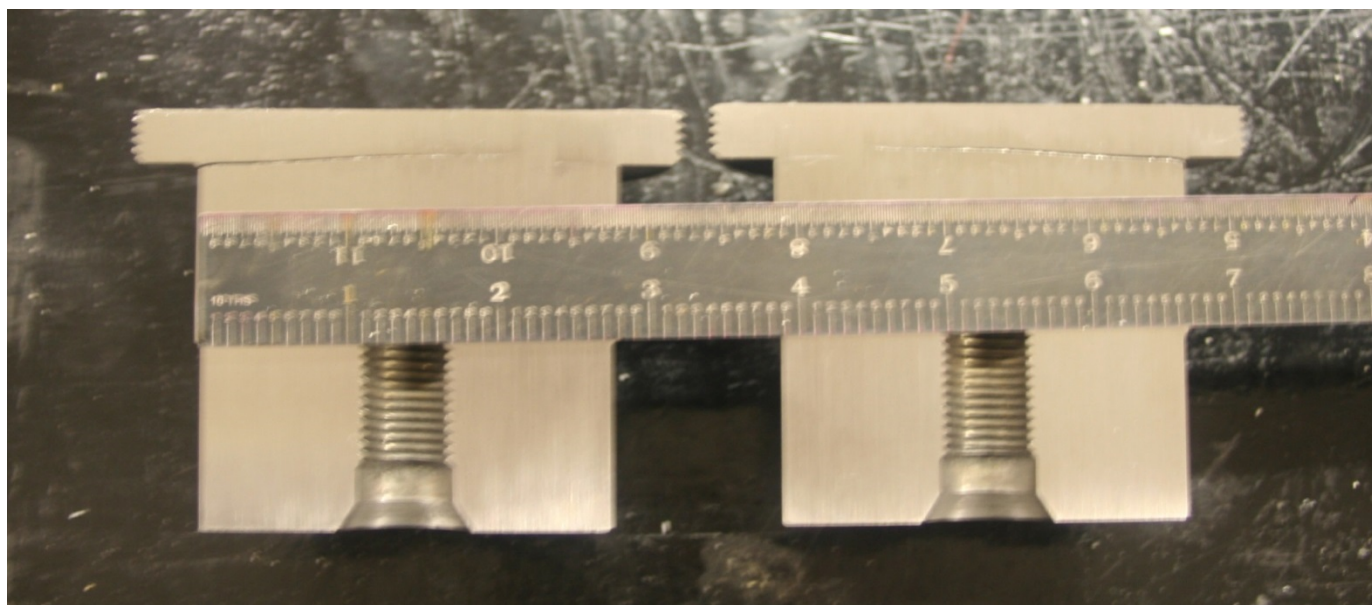
Figure 6 – Longitudinal cut of the isolated shaft crack region

The fracture region was isolated from the bulk shaft and further sectioned longitudinal to detail the crack propagation in the profile view. The image shows the propagation past the center point, with a minor crack also evident on the opposite side meeting at the plane of retained metal.

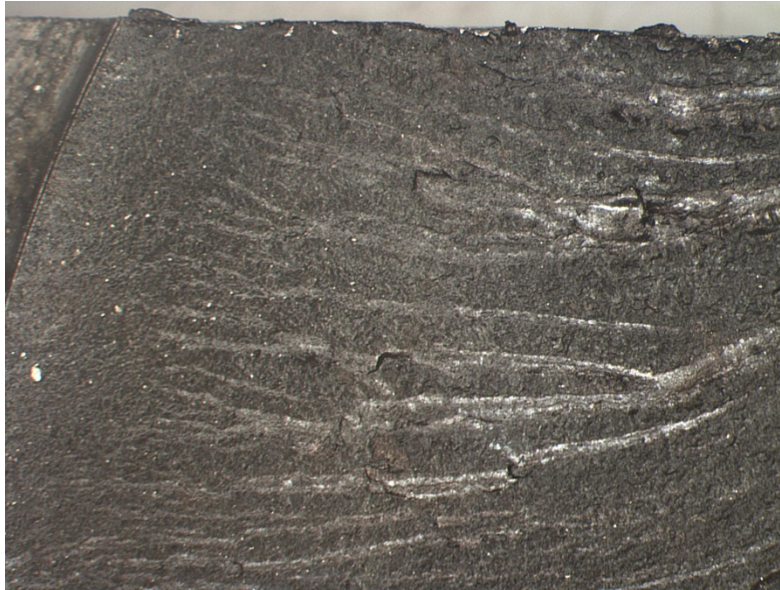
**Figure 7 – Photomicrograph obtained from fracture area A at 7X magnification**

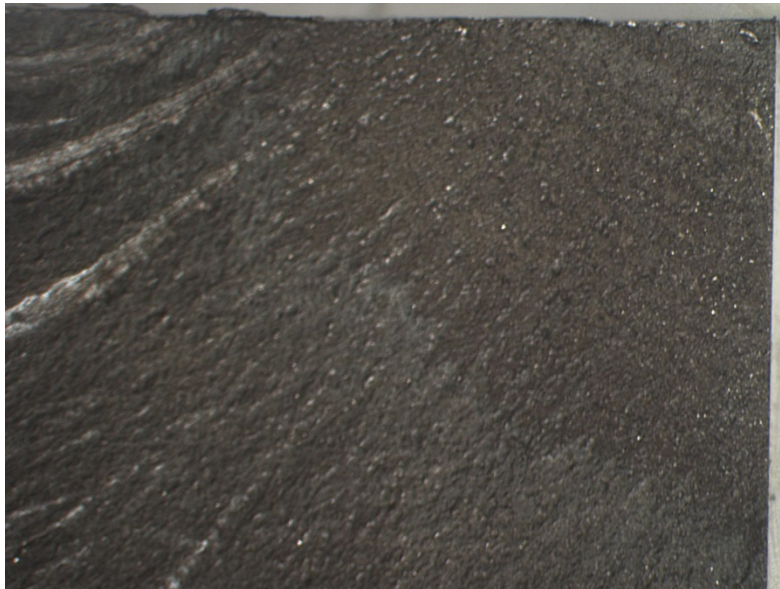
**Figure 8 – Photomicrograph obtained from area B at 7X magnification**

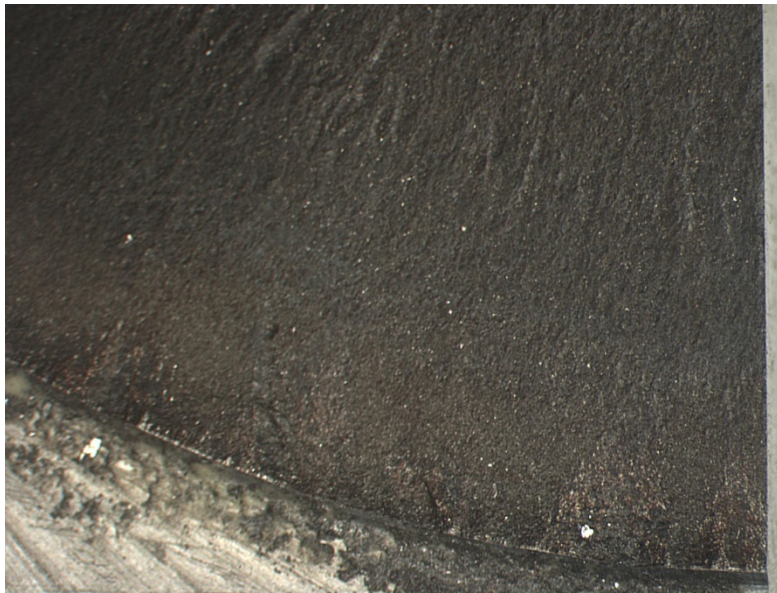
**Figure 9 – Photomicrograph obtained from area C at 7X magnification**

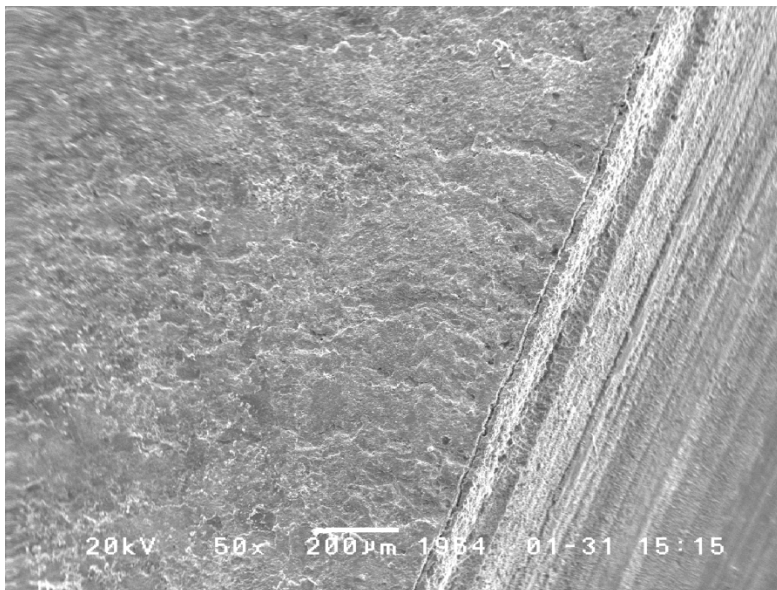
**Figure 10 – SEM photomicrograph obtained at 50X magnification at the circumference area**

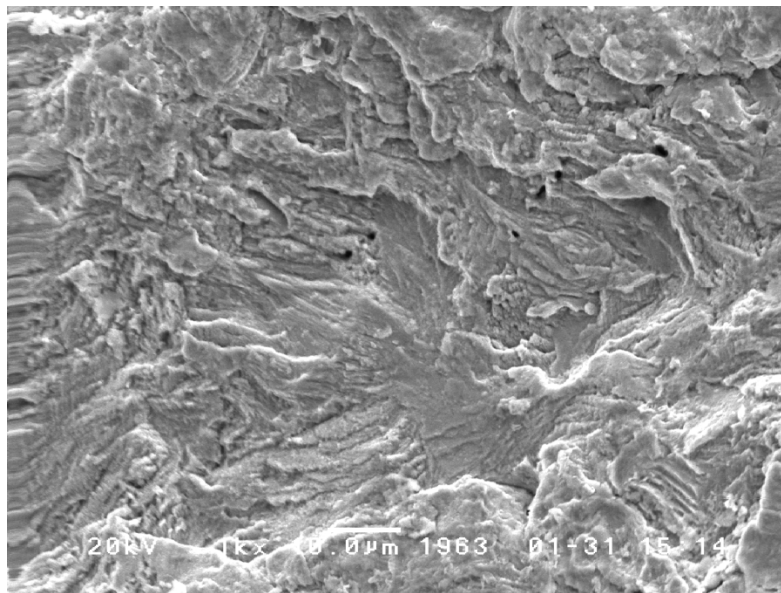
**Figure 11 – SEM photomicrograph obtained at 1000X magnification at the circumference area indicating cleavage morphology**

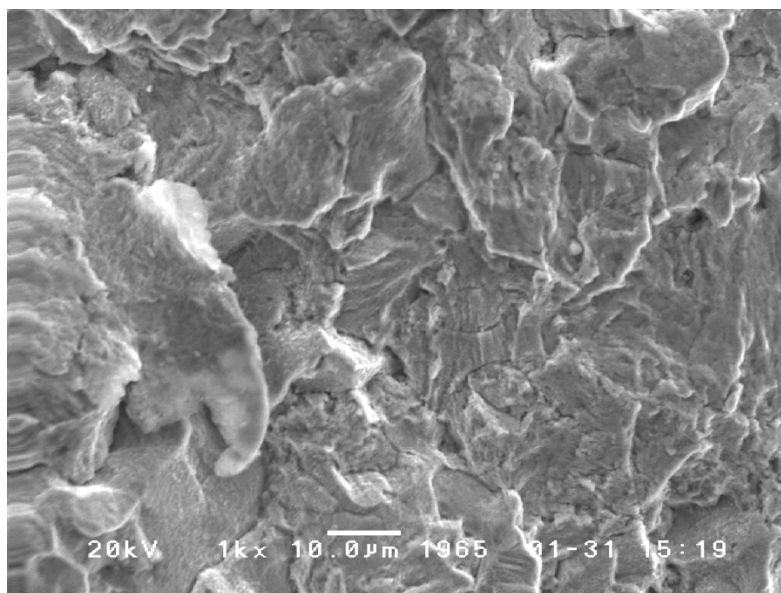
**Figure 12 – SEM photomicrograph obtained at 1000X magnification at the center area indicating cleavage morphology**

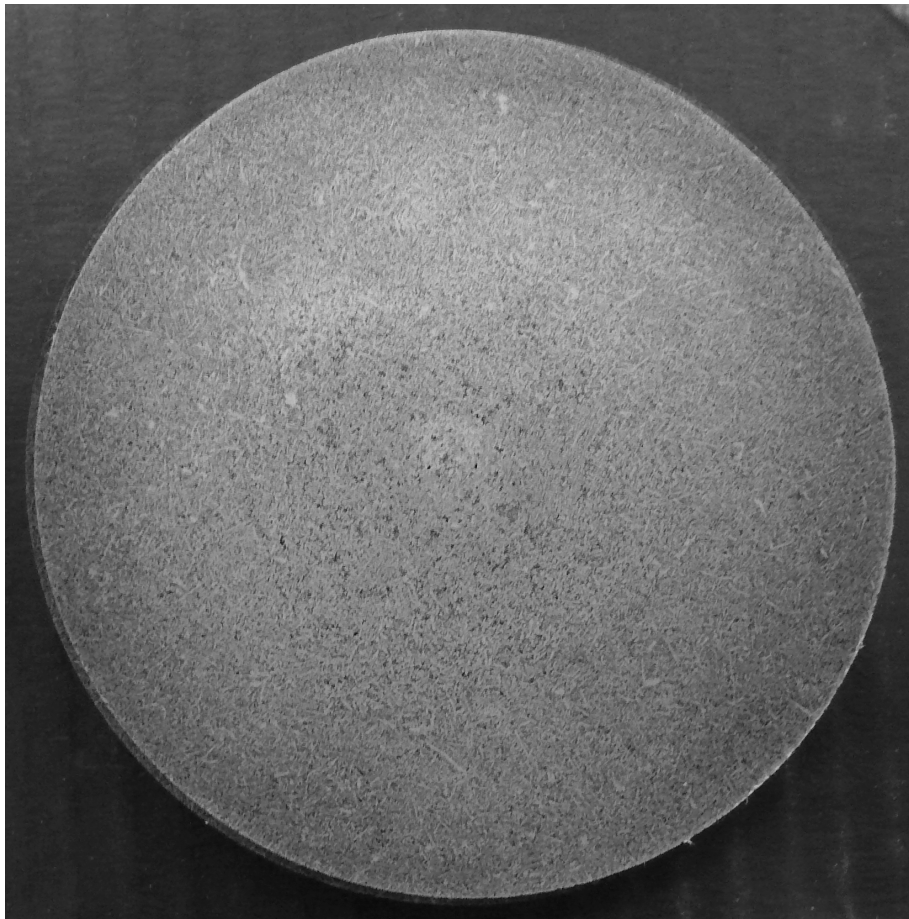
Figure 13

The sample was not gassy. There was no flute cracks, butt tears, flake or splash. Please see Macro-image 13, which follows.

**Macro-image showing the macrostructure throughout cross-section.**

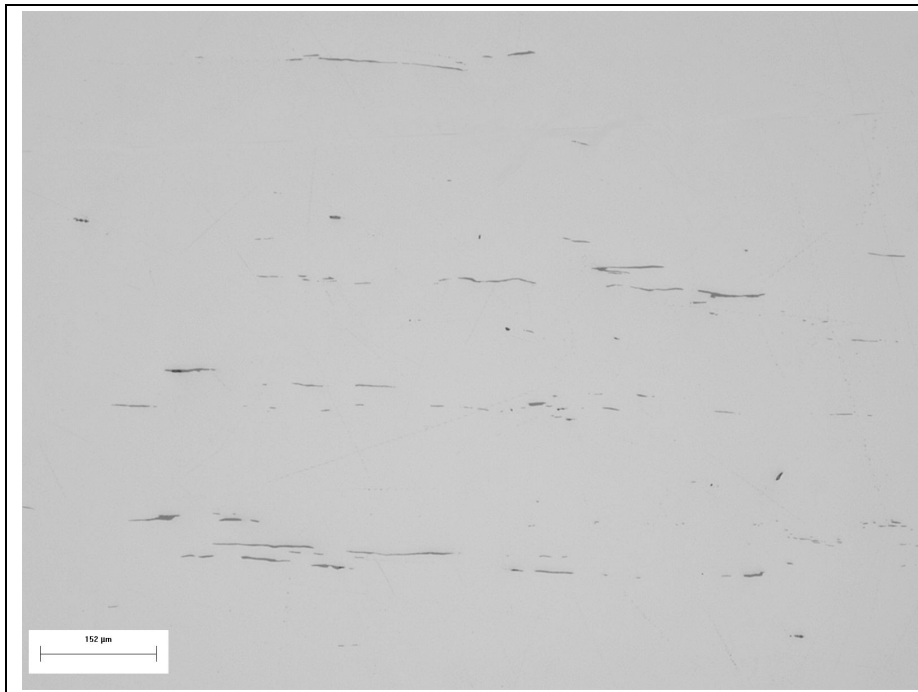
Metallographic examination of the as polished longitudinal cross-section revealed numerous non-metallic inclusions throughout the matrix, which was rated at 100x for inclusion content of the steel by comparing with ASTM E45-10<sup>e1</sup>, method A, Plate I. (see fig.14)

**Figure: 14****Magnification:** 100X**Condition:** As-Polished**Comments:** Micro-image of representative structure.

It should be noted that the high concentrations of non-metallic inclusions in the matrix and banded microstructure will decrease fatigue life of the material under cycle loading.

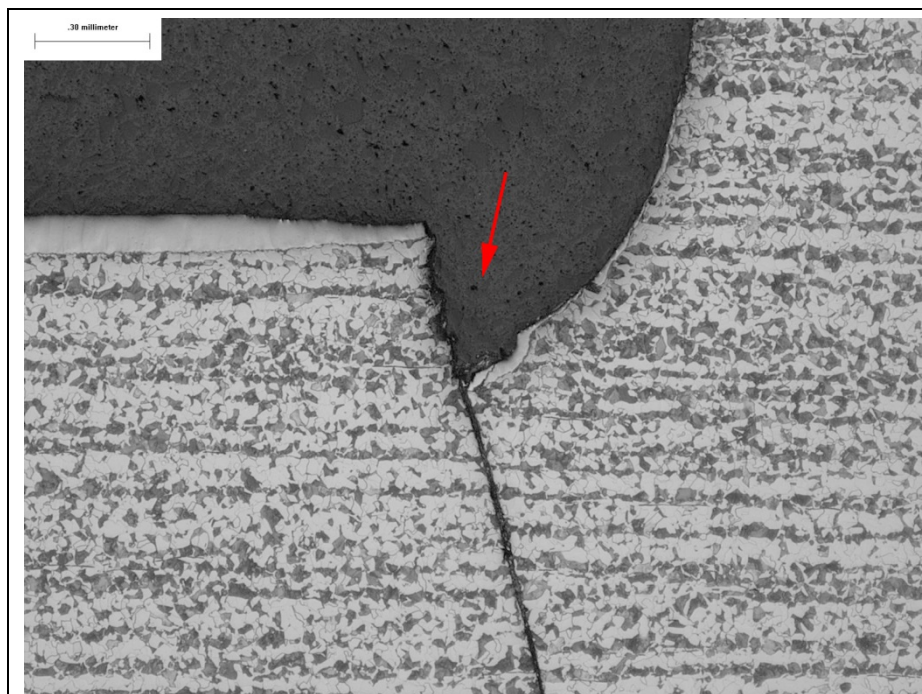
Metallographic examination of the etched cross-section under a low power microscope, revealed presence of the undercut at the sharp machined radius. The trans-granular crack originated from the step in undercut (see fig.15 red arrow) and progressed inward. Metallographic examination of the etched cross-section at higher-magnification revealed banded microstructure, which consists of continuous bands of fine lamellar pearlitic colonies in the ferritic matrix. (see fig.16) The average equiaxed ferritic grain size was estimated to be 7.0 in the section examined as rated to ASTM E112-10.

**Figure: 15****Magnification:** 50X**Condition:** Etched with Nital**Comments:** Micro-image illustrates undercut at the small machined radius and crack origin.

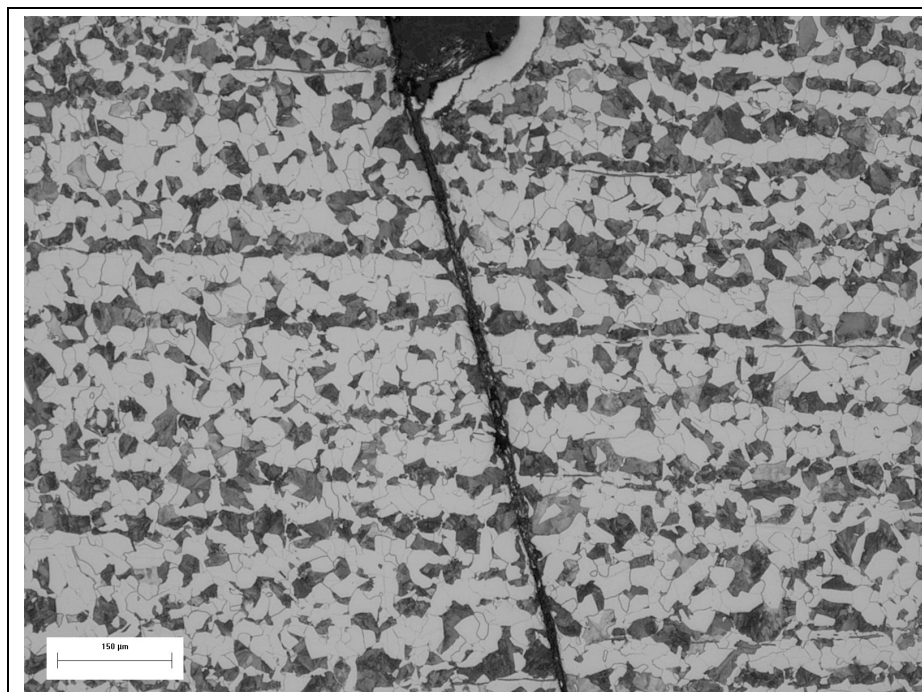
**Figure: 16****Magnification:** 100X**Condition:** Etched with Nital**Comments:** Micro-image of representative structure.
