RTI Tracking Number:	1402032	Date: 2/11/2014
Core Task:	Chemical Analysis , Mechanical Testing, Metallurgical Testing	
Analytical Techniques	Chem/Mechanical/Microhardness

**- Report of Analytical Services -**

RTI Lab#: 1402032-004A

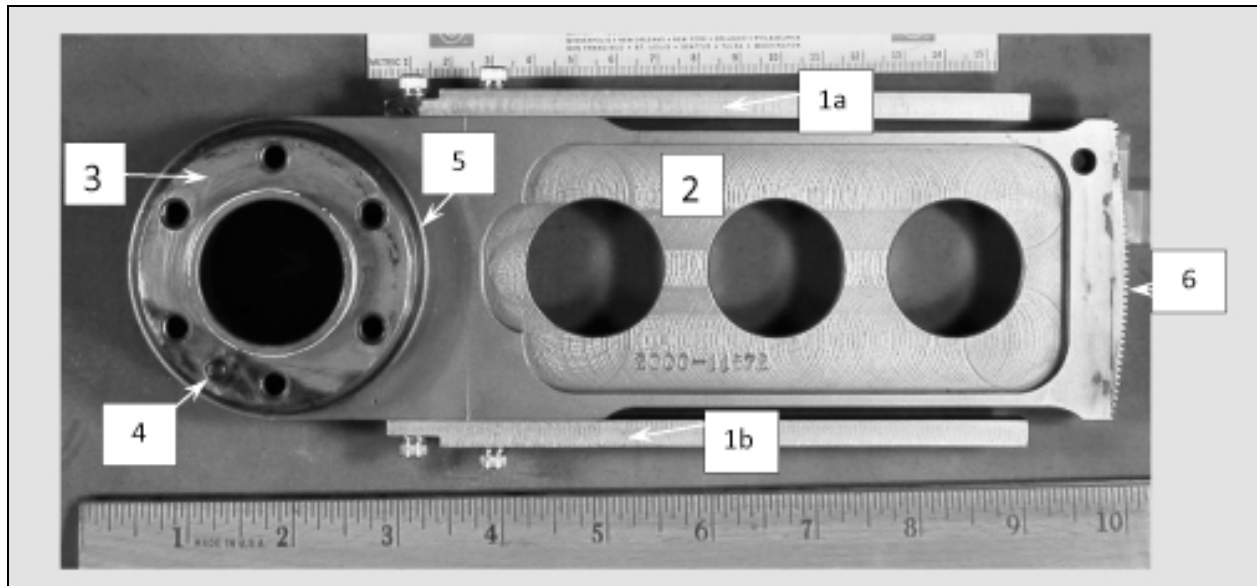
As-received for analysis.

Figure 1.  
Macro-image illustrates top view.

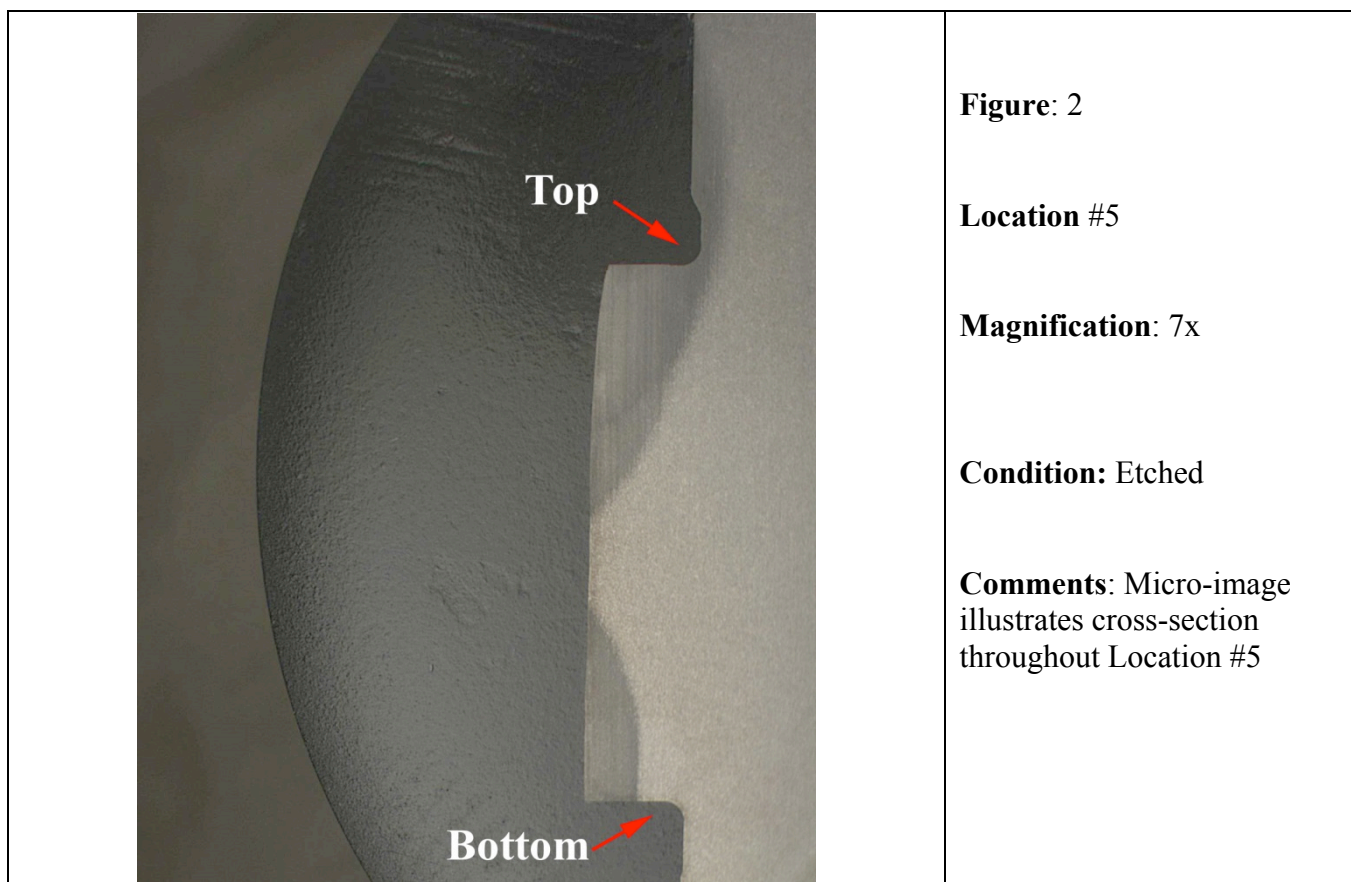
**Figure: 2**

Metallographic examination of the etched cross-section at O.D. surface at Location #5 revealed no evidence of any type of welding present (see fig.2). The O.D. circumference portion of the part at the machined radius (top and bottom portion of the part) revealed the presence of severe overheating, which most likely occurred during aggressive CNC machining operation (see fig.3).

**Comments:** Micro-image illustrates cross-section throughout Location #5

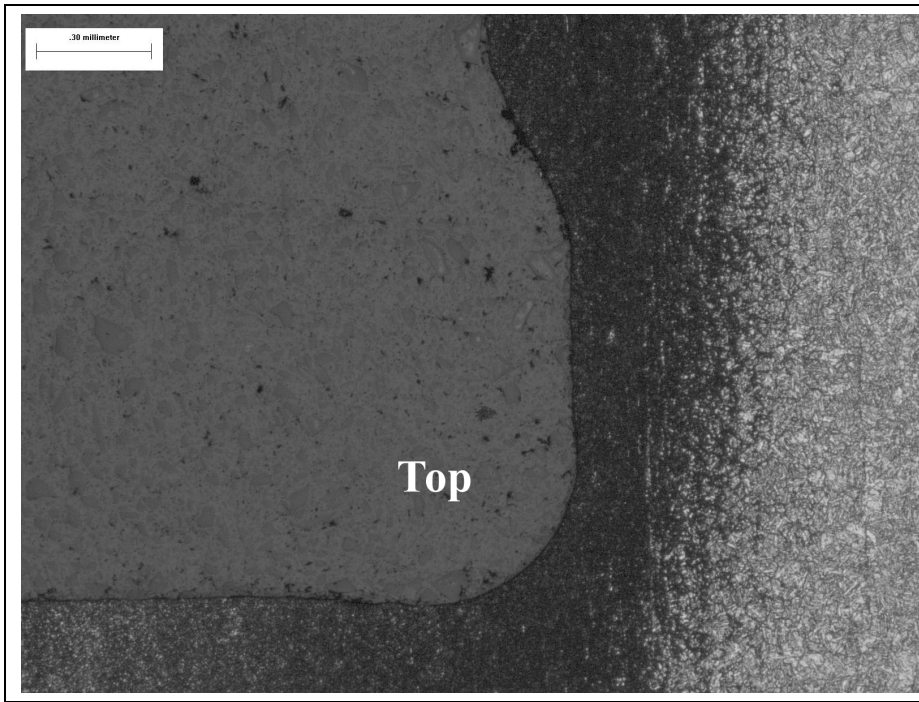
**Figure: 3**

**Comments:** Micro-image illustrates presence of the overheating at the machined radius.
