RTI PAST PERFORMANCE	
RTI Tracking Number:	1403A11 Date: 3/26/2014
Core Task:	Metallurgical Testing, Thermogravimetric Analysis, Chemical Analysis, Metallurgical Testing
Analytical Techniques	Hardness/ DSC/TGA/FTIR/SEM/EDS

Four water valve samples were received for analysis and were identified as follows:

Sample 1403A11-001A: – Good Part from Stock
 Sample 1403A11-001B: – Failed claim # 00514820T
 Sample 1403A11-001C: – Failed claim #BVXD20000352T
 Sample 1403A11-001D – Un-welded parts

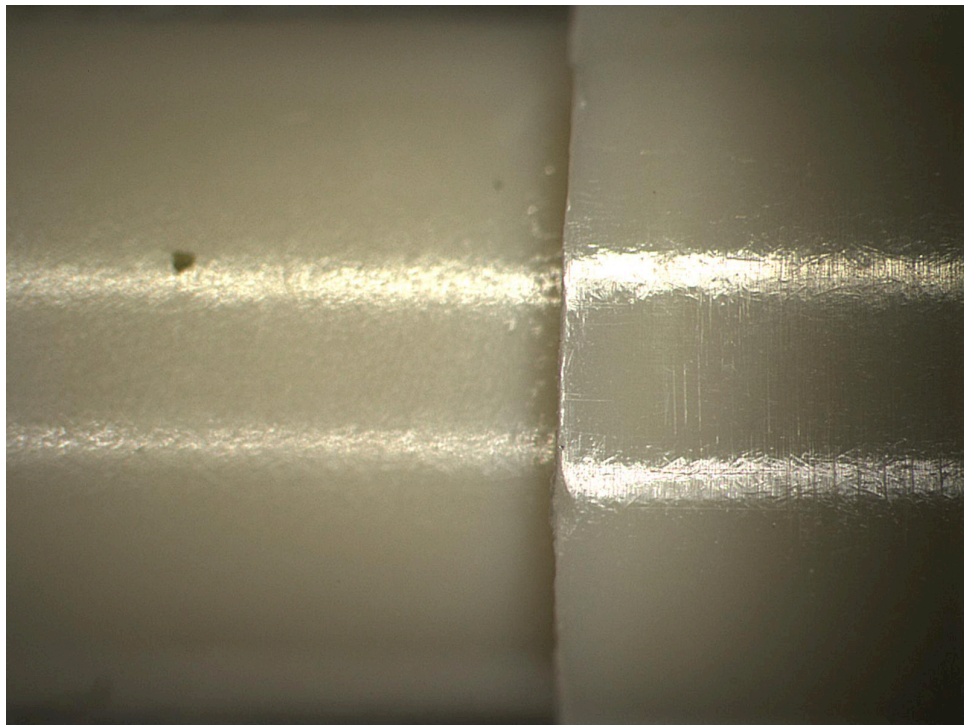
The parts were observed under magnification for possible contaminants, un-welded areas, or any notable defects in the parts. Figures 1, 2, 3 and 4 are images of the parts at 20X magnification. Figure 1 represents the post at the weld location prior to sonic welding. Figure 2 represents the stock part collar after cutting in half and pulling away from the post. This image shows a rough area where the material was welded to the post. No notable contamination or un-welded areas were found to be present. Figure 3 represents the failed post after wiping the black dirt away from the weld area. This image shows a rough area that was welded with dirt in the textured area of the broken weld. The black material/dirt is believed to be present from part use after the weld failed since this black material was present on the recess of the failed part as well. Figure 4 represents the failed collar after being sliced for observation of the weld area. This image shows the weld line that had failed as well as excess loose polymer/filler material that is believed to have been formed during the sonic welding process of the parts.

Figure 1: Sample 1403A11-001D Post Un-welded

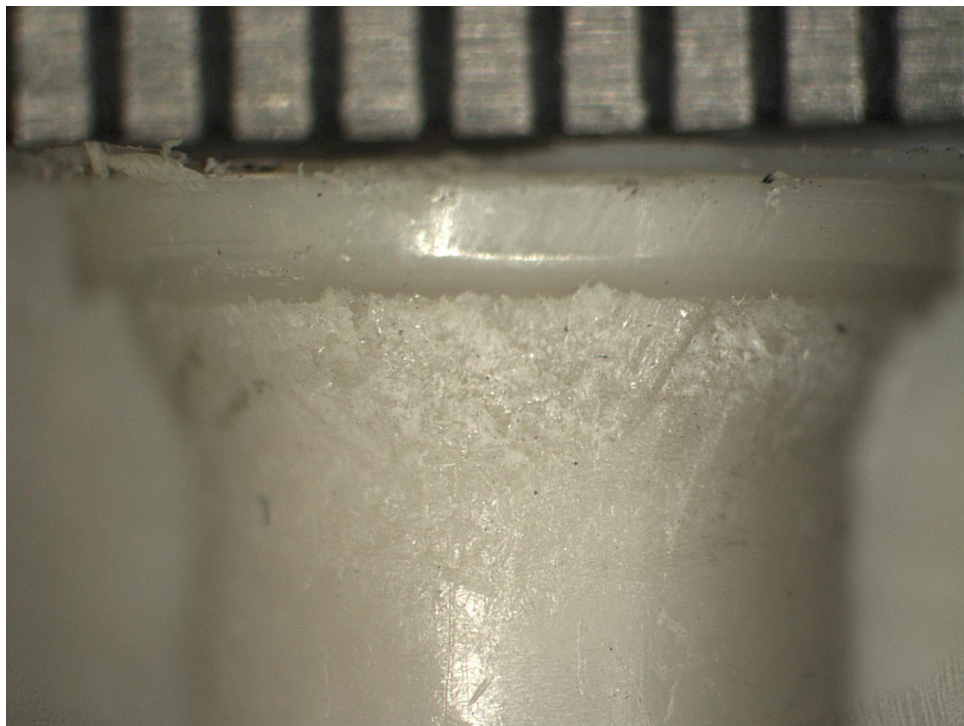
Figure 2: Sample 1403A11-001A stock part collar

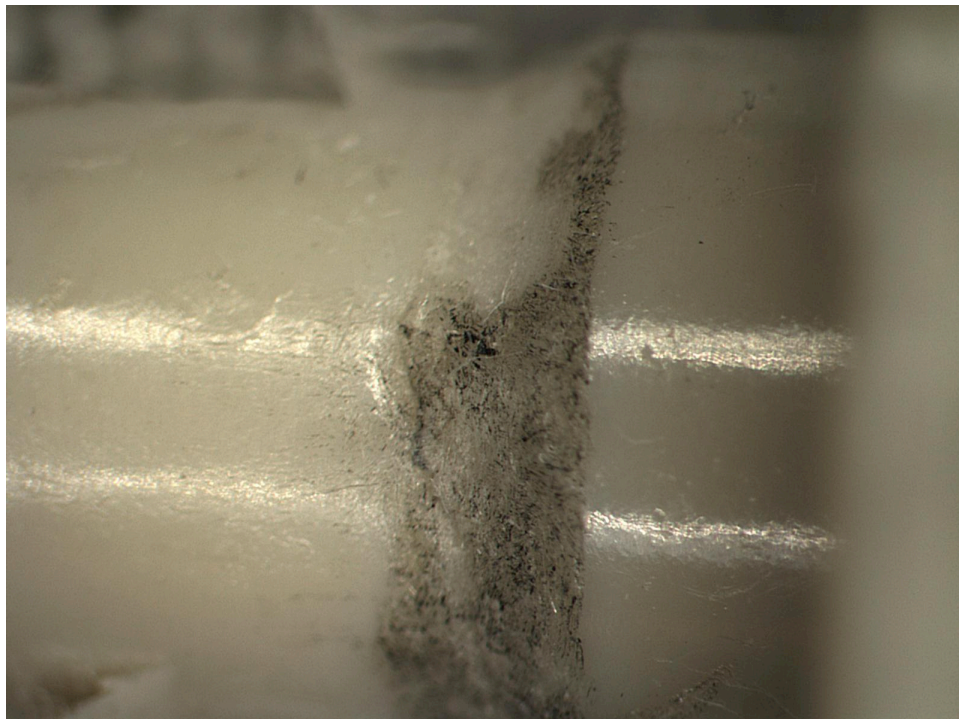
Figure 3: Sample 1403A11-001B failed post

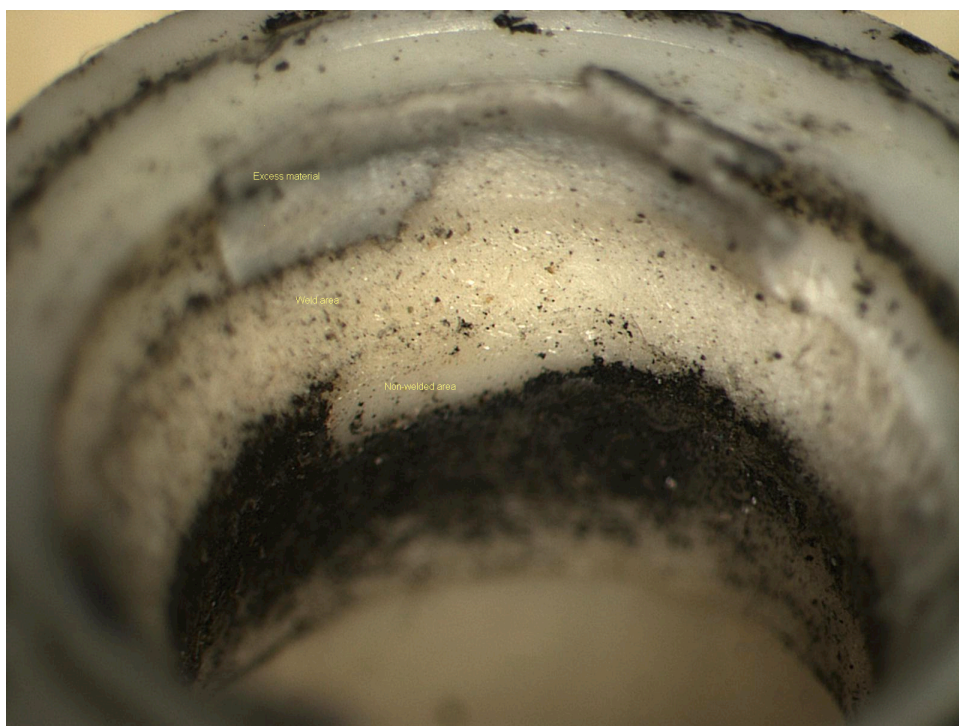
Figure 4: Sample 1403A11-001B failed collar

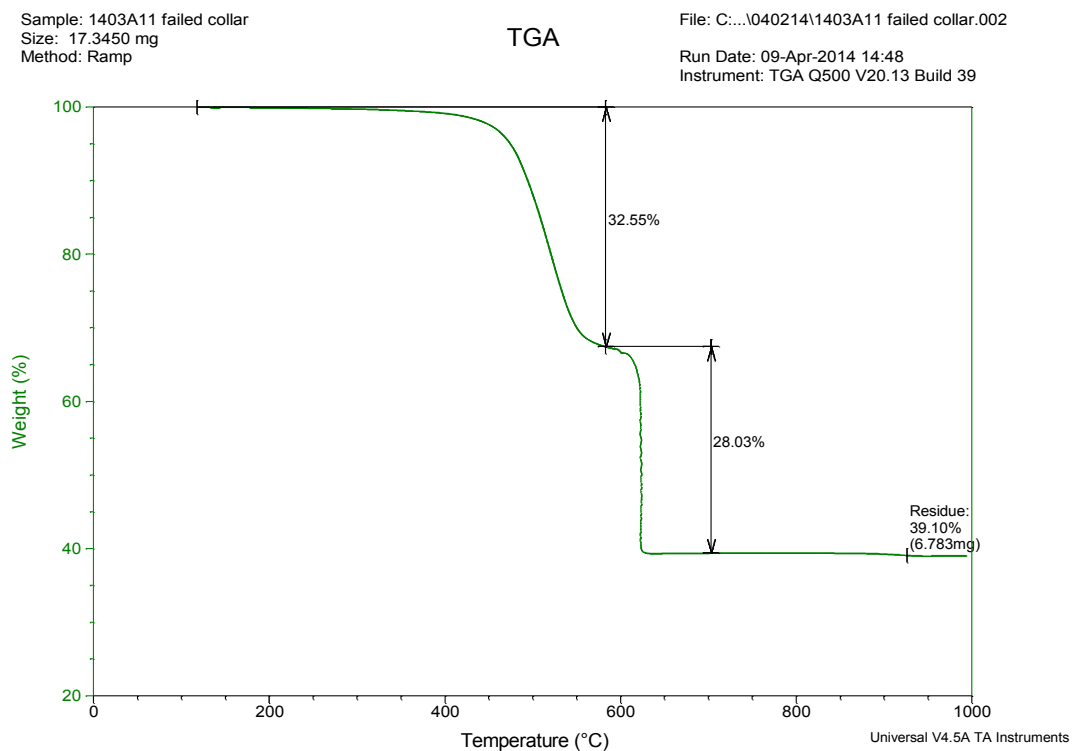
Figure 9: TGA Thermal graph of failed part collar around weld area

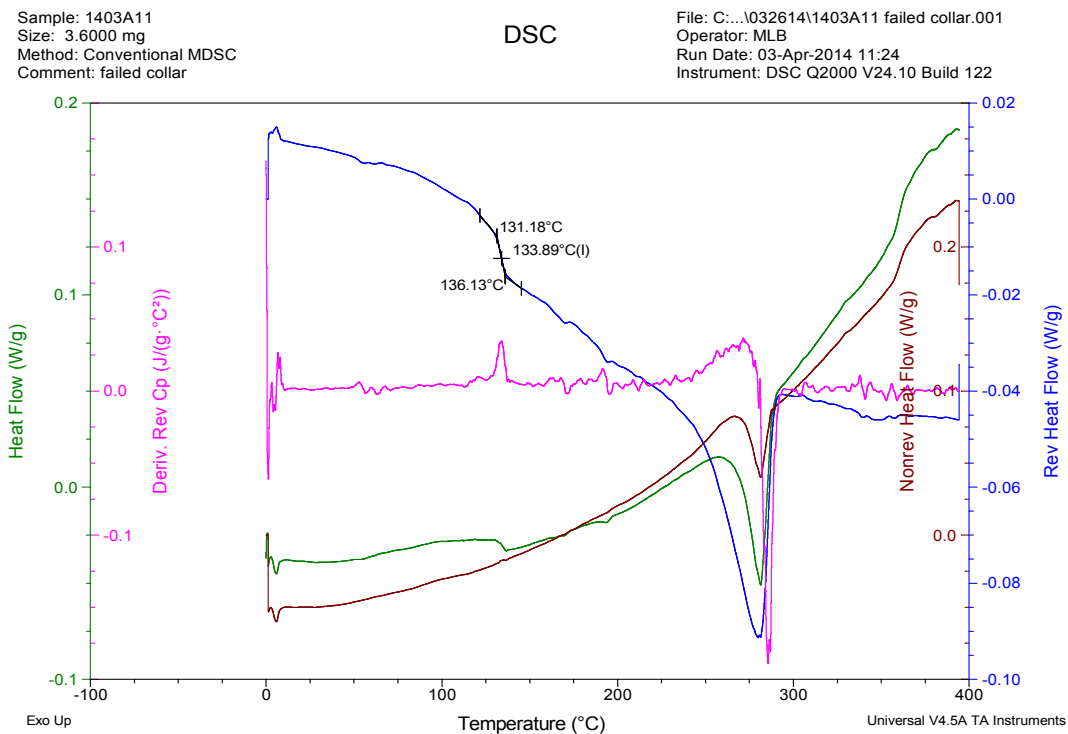
The failed part was found to have a higher glass transition temperature that indicates the polymer composite has become brittle over time most likely due to environmental stress.

Figure 14: DSC thermal graph of failed collar around weld area

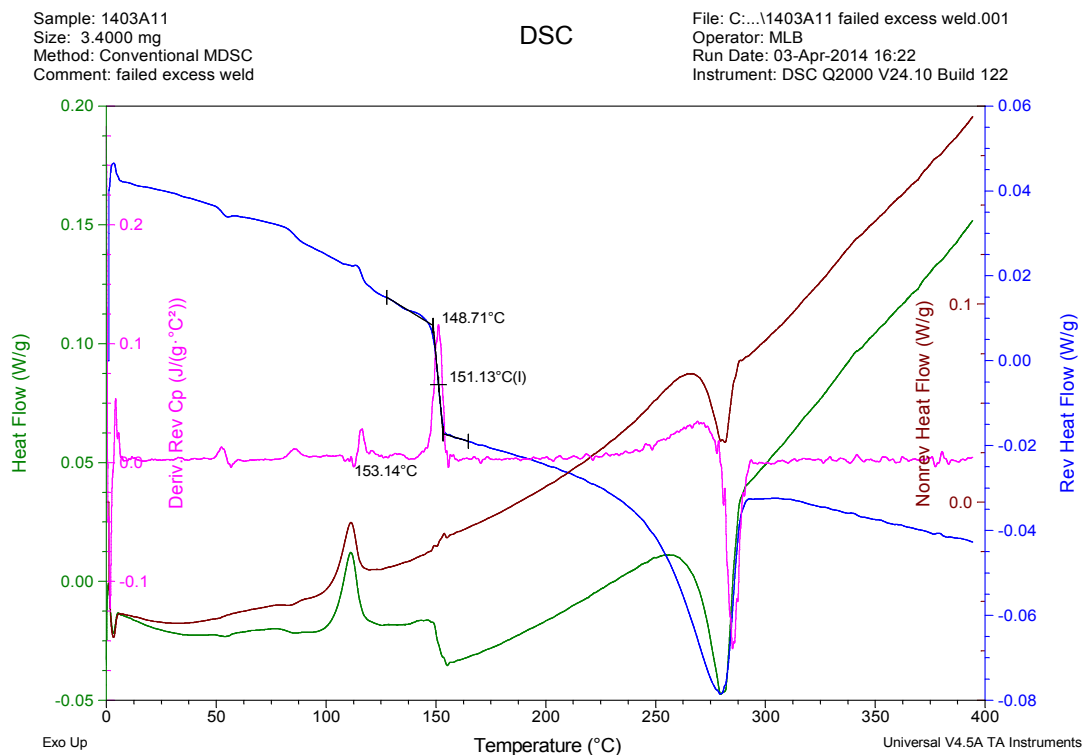
Figure 15: DSC thermal graph of excess PPS of failed part around weld area

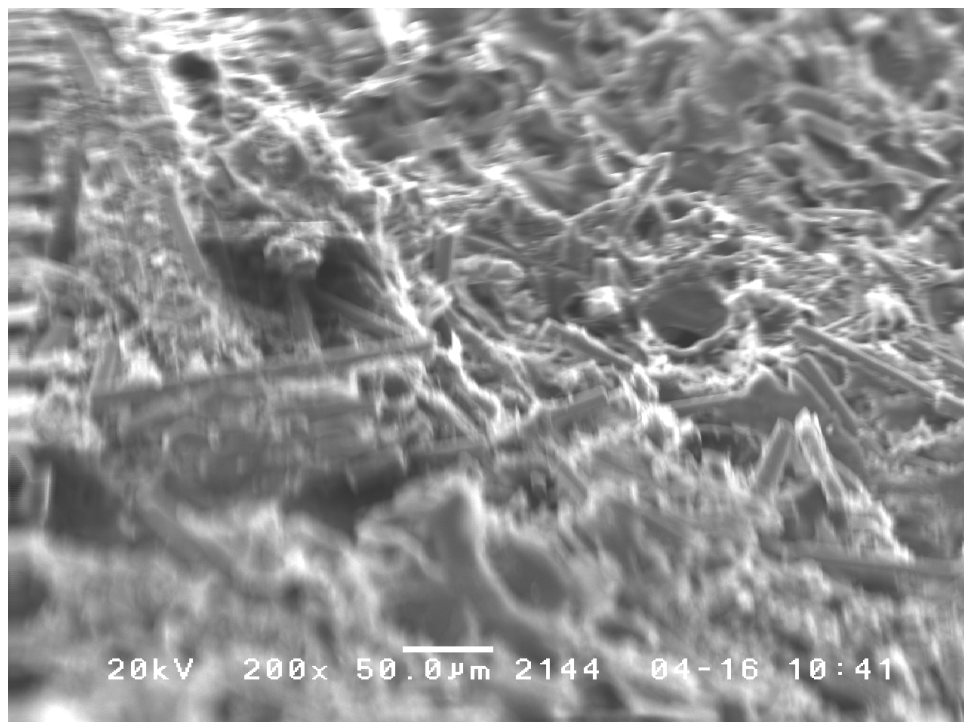
SEM/EDS analysis was performed on the inside portion of the collar at the weld interface of Samples 1403A11-001A (stock good part) and 1403A11-001B (failed part). Figures 23 and 24 represent the SEM images of the weld interface. The SEM image of the failed collar weld appears to be slightly smoother at the weld break that can be representative of a brittle failure. EDS analysis of the weld interface is shown in Figures 25 and 26. EDS of the failed weld indicates the presence of potassium not found to be present in the stock weld sample. This would indicate possible environmental stress due to a potassium rich material. Although we can not know the nature of the potassium material if it were an alkali material such as potassium hydroxide the base material PSS has limited suitability to this type of material and would fail over time.

Figure 23: SEM image of Sample 1403A11-001A (good stock part)

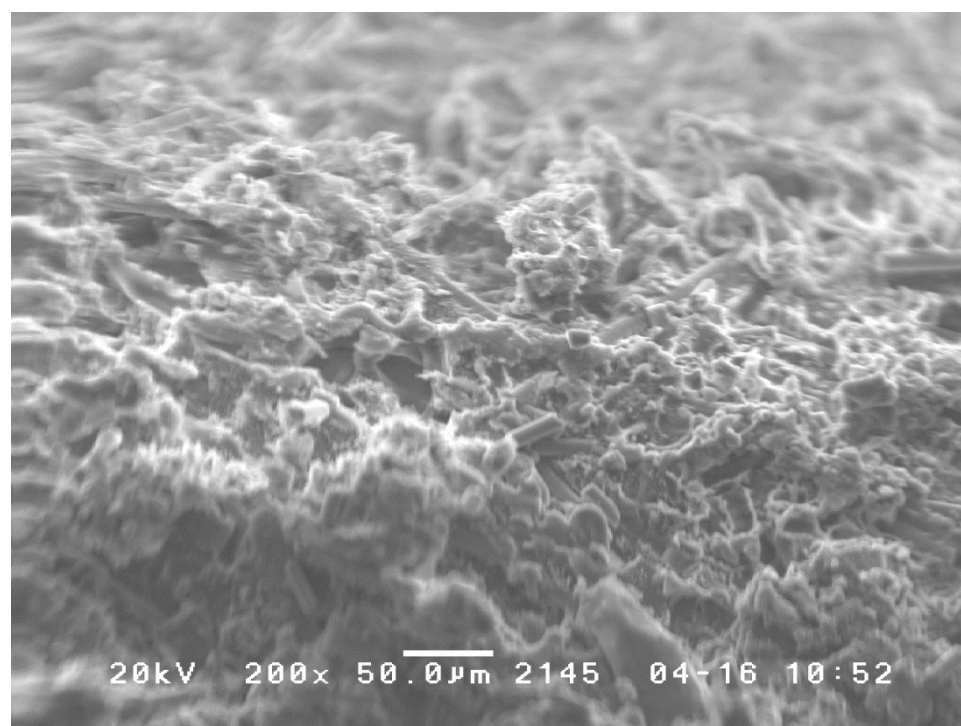
Figure 24: SEM image of Sample 1403A11-001B (Failed part)

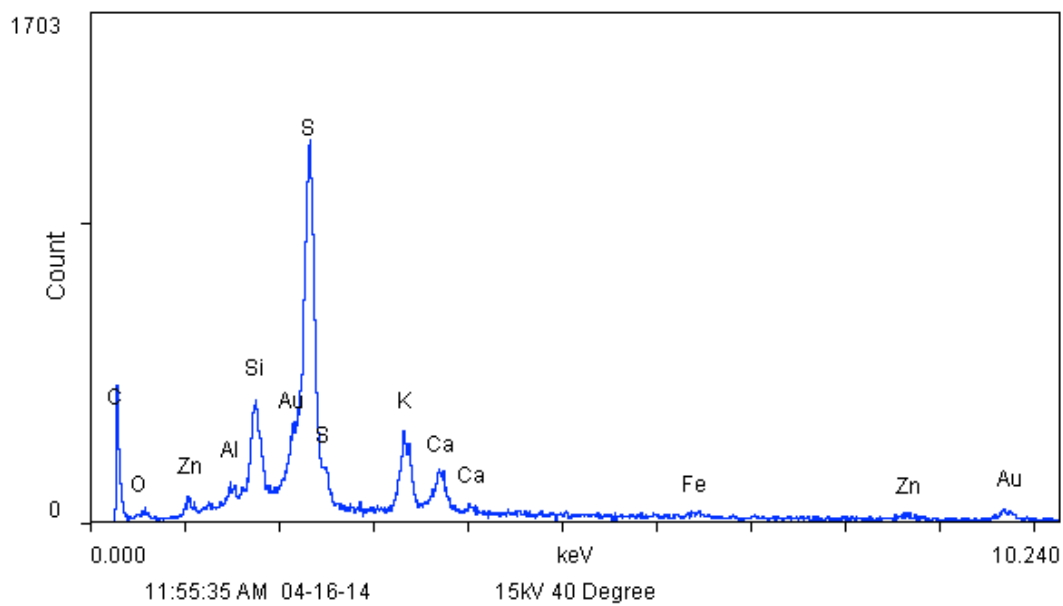
Figure 26 – EDS of Sample 1403A11-001B (Bad Weld)

The polyphenylene sulfide (PSS) in the weld area of the failed part was found to have an increased glass transition temperature and a potassium contamination not found to be presents in the stock welded part. This increased glass transition temperature will cause the polymer to become more brittle and allow for fractures more easily than the stock part typically known as brittle failures. The presence of the potassium indicates a possible chemical attack. Although we cannot determine the source or nature of the potassium if it was present in alkali form and at elevated temperatures it would attack the PSS and weaken it over time. It is known that PSS has limited suitability in the presence of alkali chemicals which can lead to brittle failures as seen with this part.
