RTI PAST PERFORMANCE		
RTI Tracking Number:	1408703	8/18/2014
Core Task:	Chemical Analysis , Metallurgical Testing	
Analytical Techniques	Chem/Feature/Microhardness/SEM/Photo

### **Metallographic observations:**

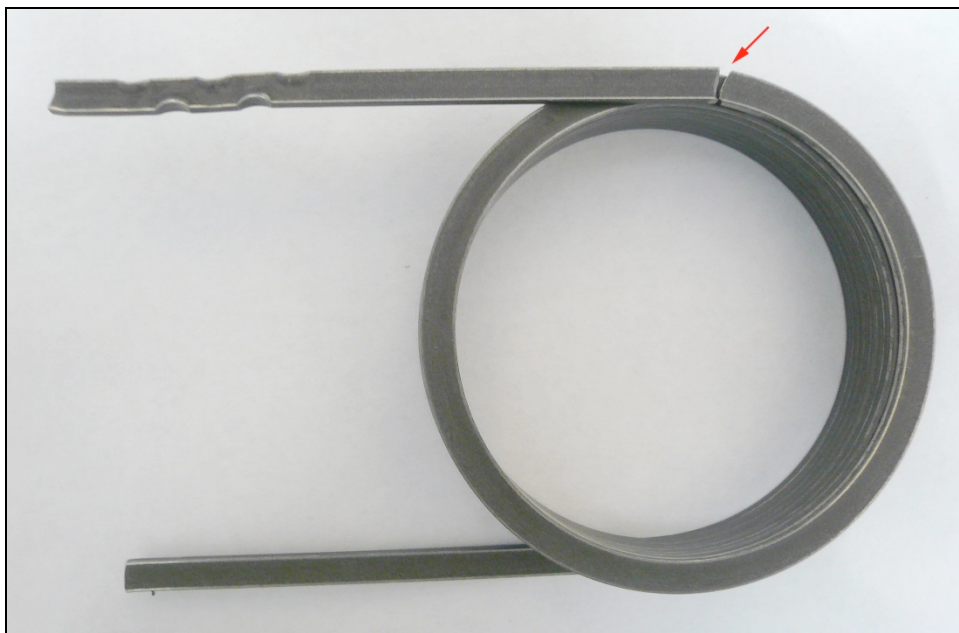
Figure 1.

The failed during testing clutch spring was received for analysis (See Fig 1). The target of the analysis was to investigate the nature of the failure by using a variety of the metallographic techniques. It should be noted that adjacent components were made available for the submitted spring. The results of the analyses are provided below.

Red arrow points to the fractured region.

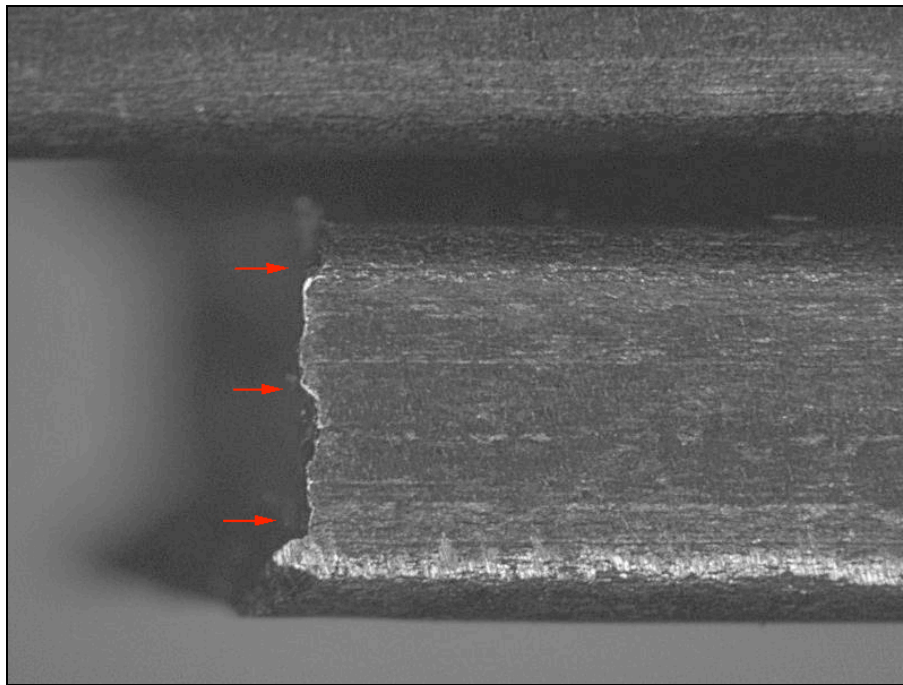
Figure 2.

1. Location of the fracture suggests that the part is exposed to the highest stress at the beginning of the first revolution of the spring during service.
2. Examination of the fractured surfaces at low power magnification revealed that the fracture originated at the top (O.D.) surface of the spring coil. The top of the fracture propagated in a straight line - perpendicular to the rolling direction of the spring wire. There is no evidence of any surface defects such as seam, pits, die marks and other defects tending to impair the use the spring wire associated with fracture origins (see fig.2).

Macro-image illustrates surface condition at the top (O.D) surface of the spring coil near the fractured region. Red arrows point to the fractured region.

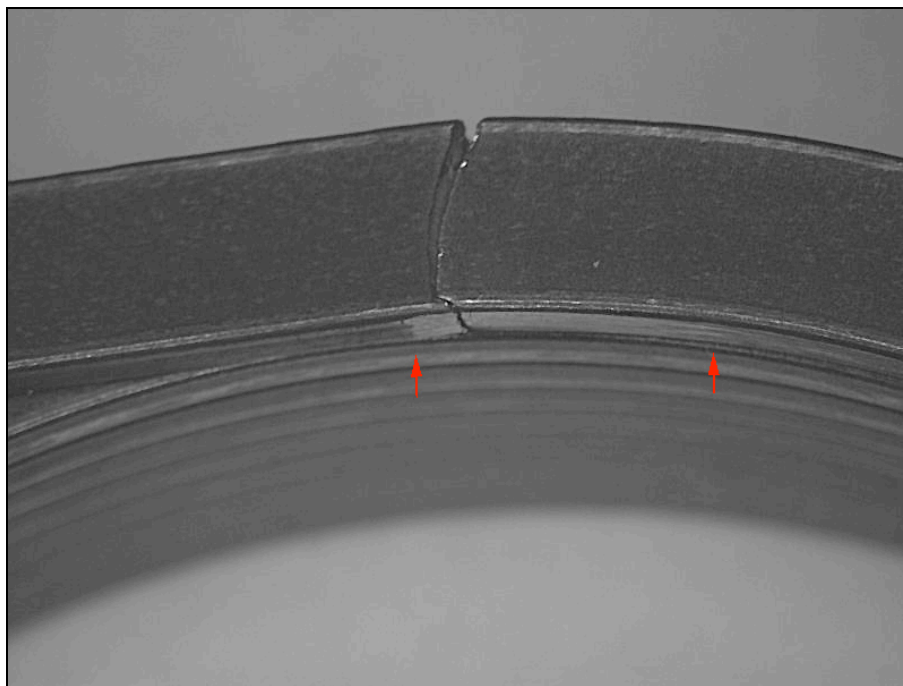
Figure 3.

3. Examination of the fractured surfaces at low power magnification also revealed that the bottom (I.D.) surface of the spring coil at the fractured region has evidence of severe abrasive material wear due to metal-to-metal contact with supporting member (See fig.3). It should be noted that the severe material wear will cause reduction of the cross-section area and respectively decreases the ultimate strength to the cyclical loading. Also, changing in cross-section geometry of the spring will inflect angle of the bending during the service and respectively increases stress at the top (O.D) tension side of the spring.

Macro-image illustrates severe abrasive material wear at the bottom (I.D.) surface of the spring near the fractured region. Red arrows point to the worn region.

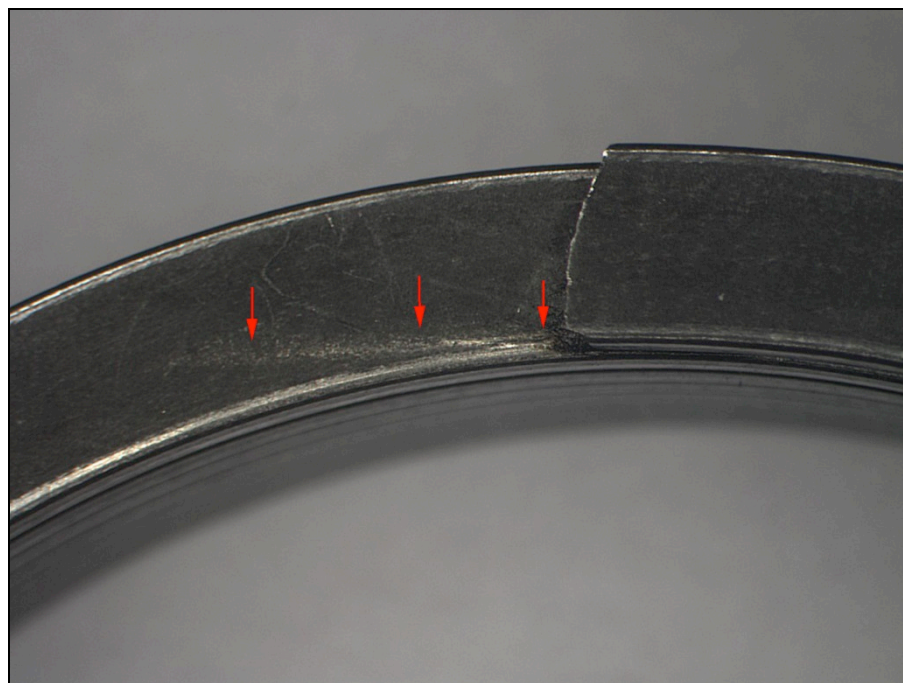
Figure 4.

4. The outer side of the second revolution of the spring coil revealed rubbing mark at the region adjacent to the fracture (see fig.4), which indicate presence of misalignment between spring and adjacent members.

Macro-image illustrates rubbing mark at the outer side of the second revolution of the spring coil.

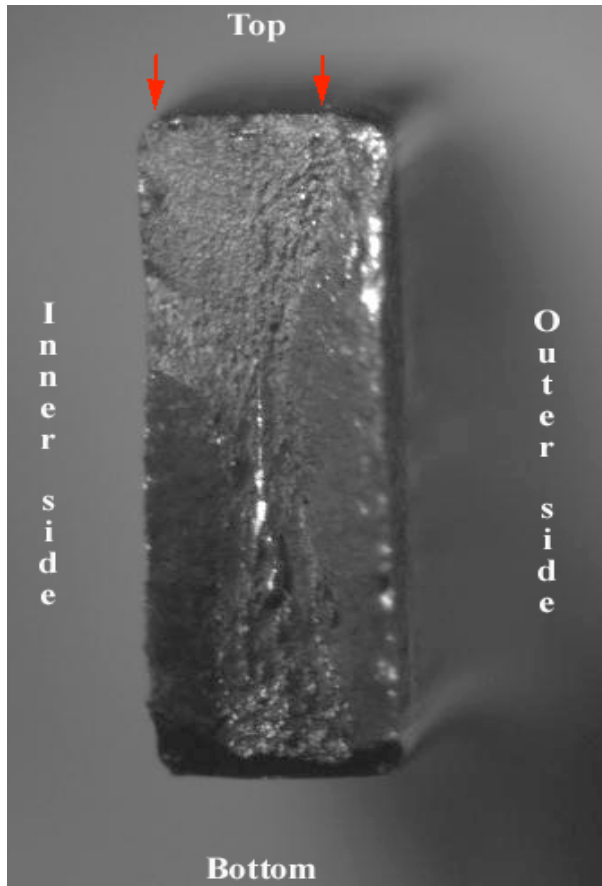
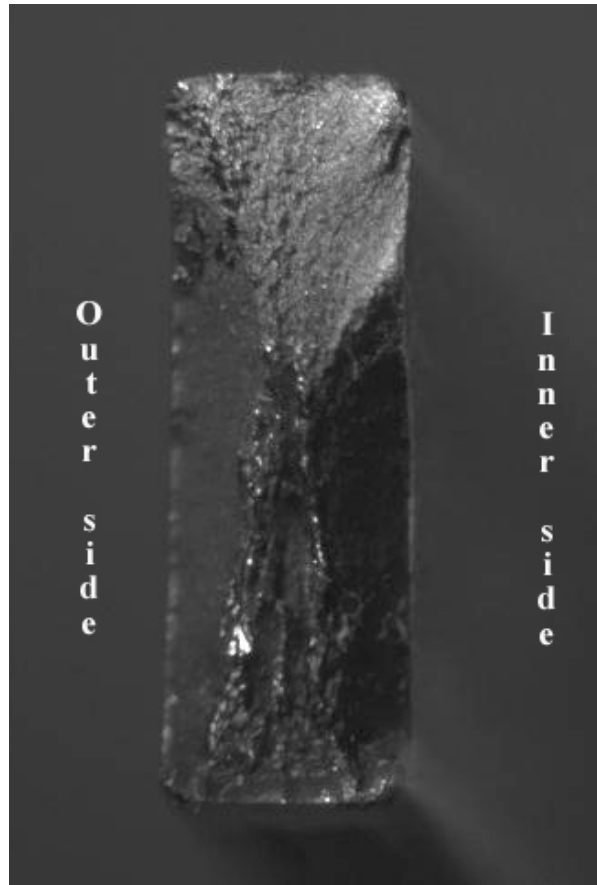
5. Macro-examination of the fractured faces at both sides revealed that the fracture-cracks originated at multiple points along the top (tension side) of the spring and propagated at an angle toward the center region of the cross-section where catastrophic final fracture occurred (Note: shear lip visible at all three side.). The offset of the origin of the fracture at the top (O.D.) side of the spring indicates misalignment and respectively presence of some torsion loading (see fig. 5 and fig.6) during service. It should be noted that the fatigue morphologies at the origins of the fractures also observed (see fig. 7).

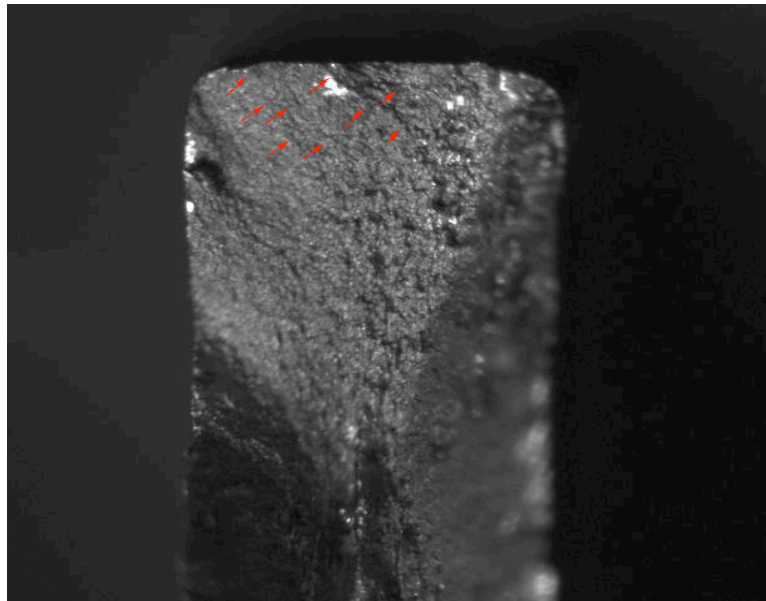
Figure 7.

Red arrows point to fatigue morphologies.

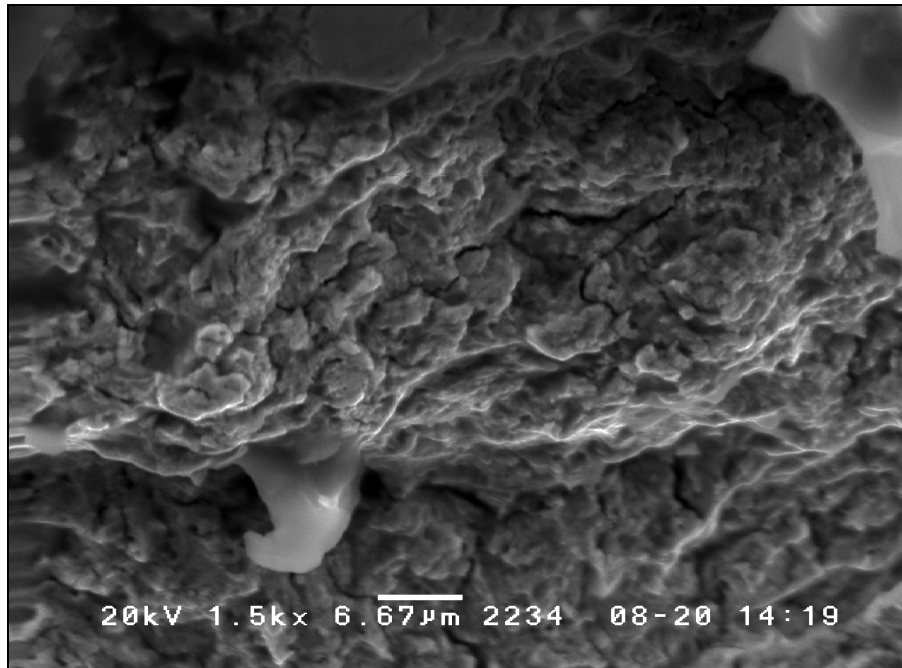
Detailed examination of the fracture surface by SEM revealed multiple-origins of fatigue cracks at the top (O.D. surface) surface of the spring wire, which extended almost through the cross-section before final rupture occurred (see fig. 8 & fig.9).

SEM Figure 8. 1500x  
SEM image illustrates fatigue morphologies at the top surface of the spring wire.

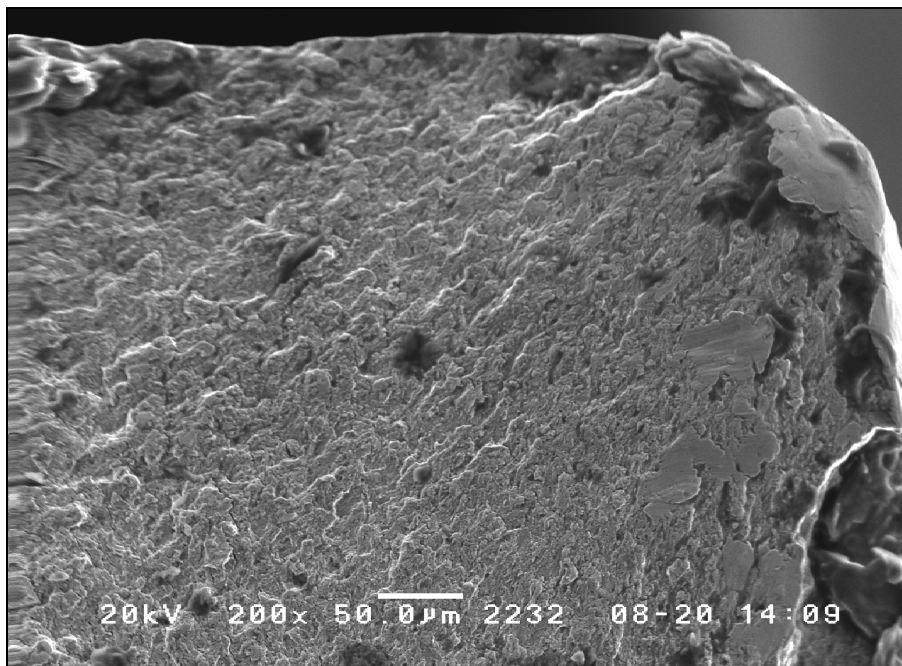
SEM Figure 9. 200x  
SEM image illustrates fatigue morphologies extended almost through the cross-section before final rupture occurred.

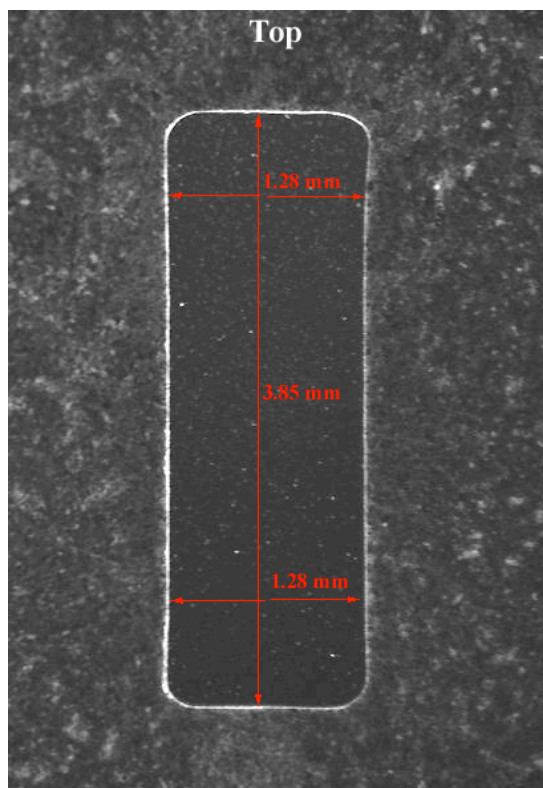
The transverse cross-section of the polished specimen illustrates the profile of the spring and dimensions (see fig.10). It should be noted that the spring actual dimensions is at the lower limit of blueprint requirement.

As-polished condition. Figure 10. 20x  
Macro-image illustrates profile of the spring and dimensions.

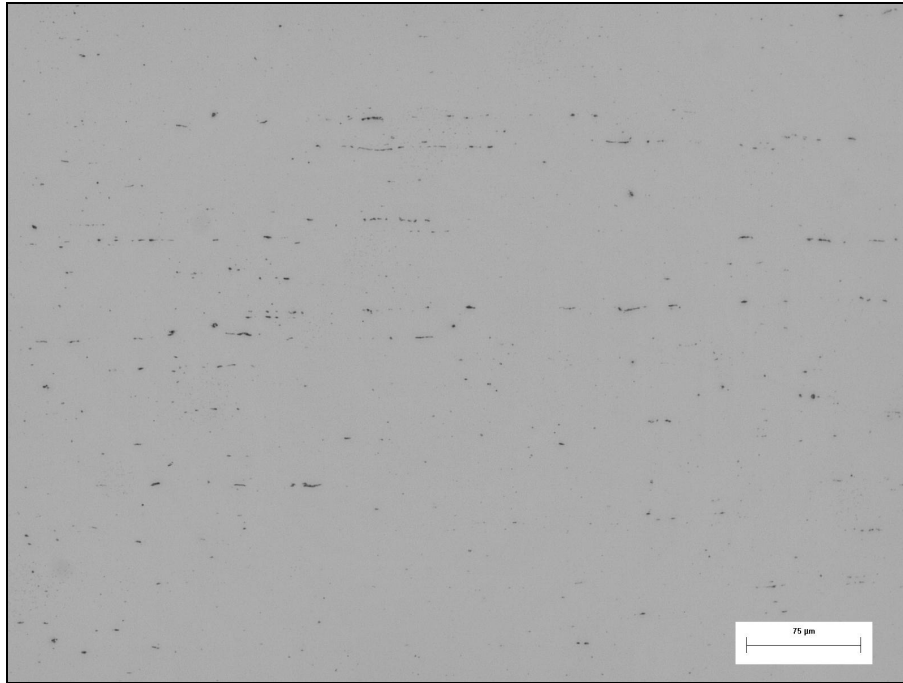
Metallographic examination of the as polished longitudinal cross-section revealed numerous linearly distributed plastically deformed non-metallic inclusions (see fig.11). The density and amount of the non-metallic inclusions is slightly above then typically observed.

As-polished condition. Figure 11. 200x  
Micro-image of a representative structure.

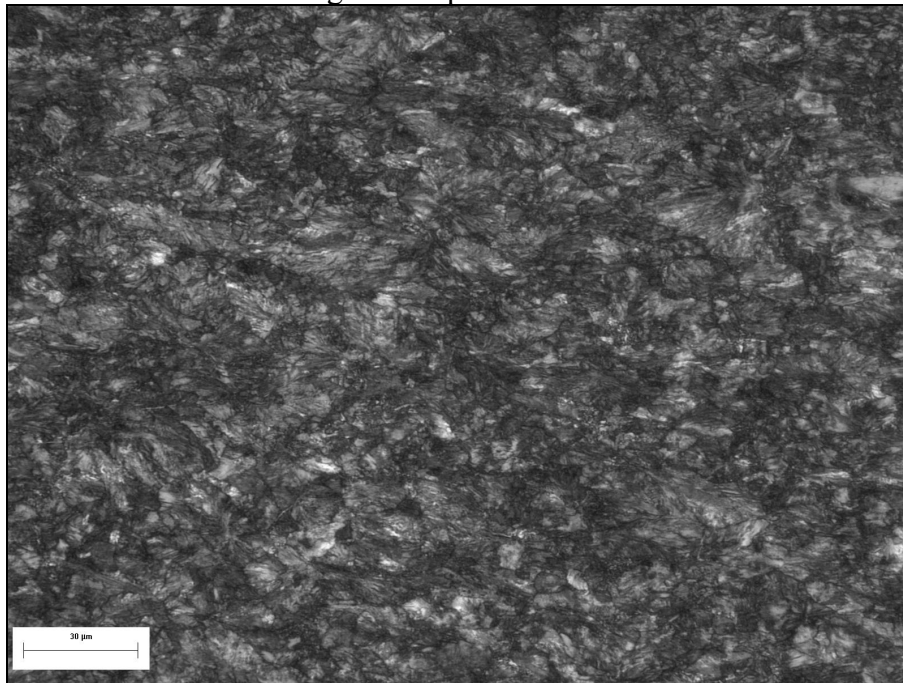
Metallographic examination of the longitudinal etched cross-section revealed a uniform microstructure throughout the matrix, which consists of what appears to be deformed pearlitic colonies (prior structure was very fine lamellar pearlite) (see fig.12).

Etched with Nital. Figure 12. 500x  
Micro-image of a representative structure.
